Welcome to all
Vendor Meet
Participants
24.10.2024

Quality Issues in Bogie Shop

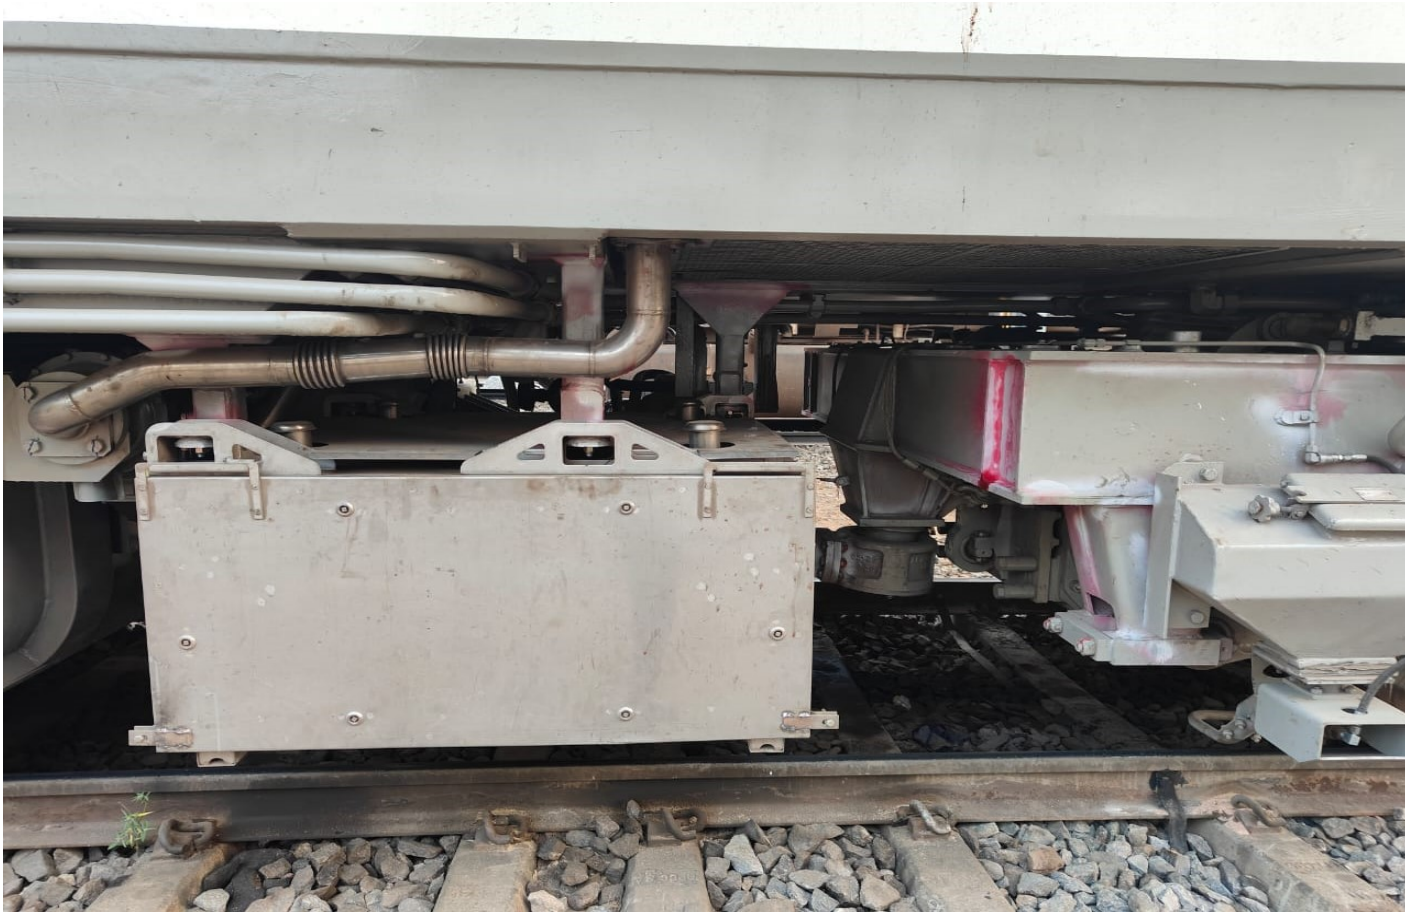
Welding Crack on Bogie Frame

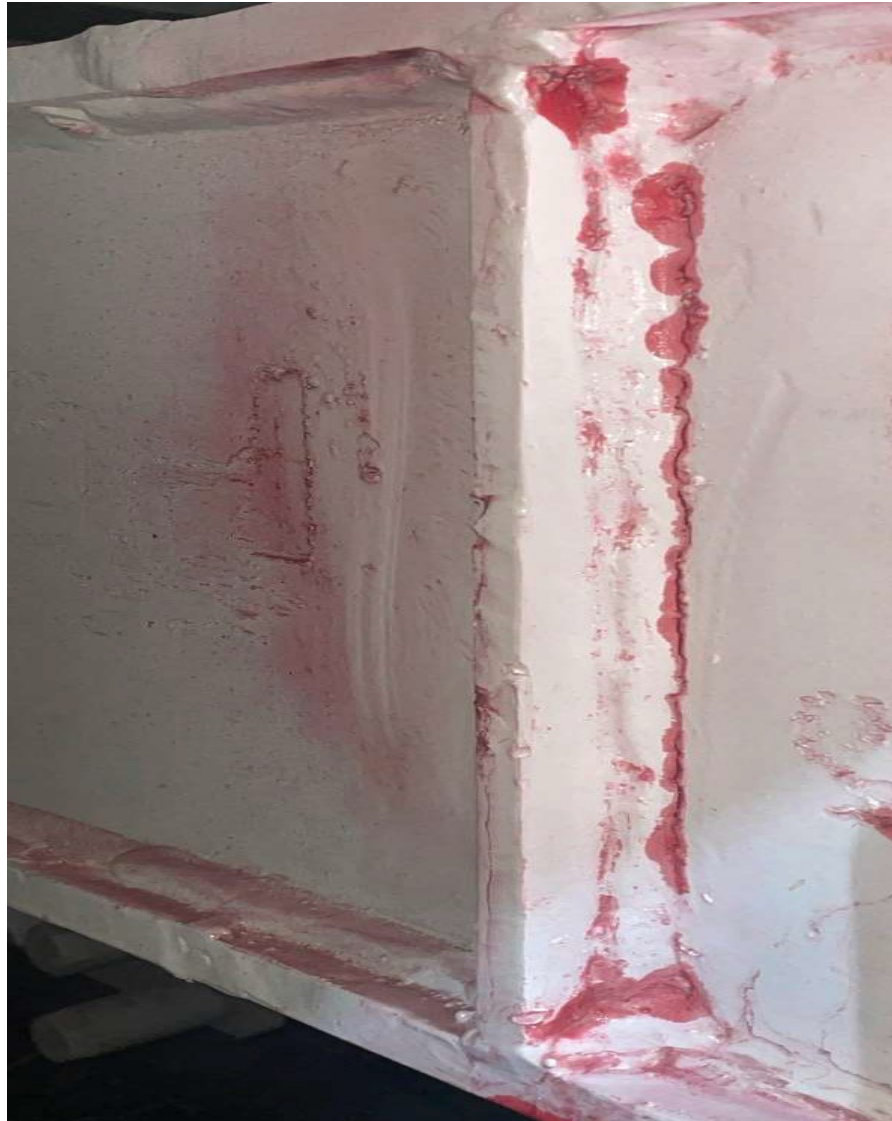
Welding Crack on Bogie Frame

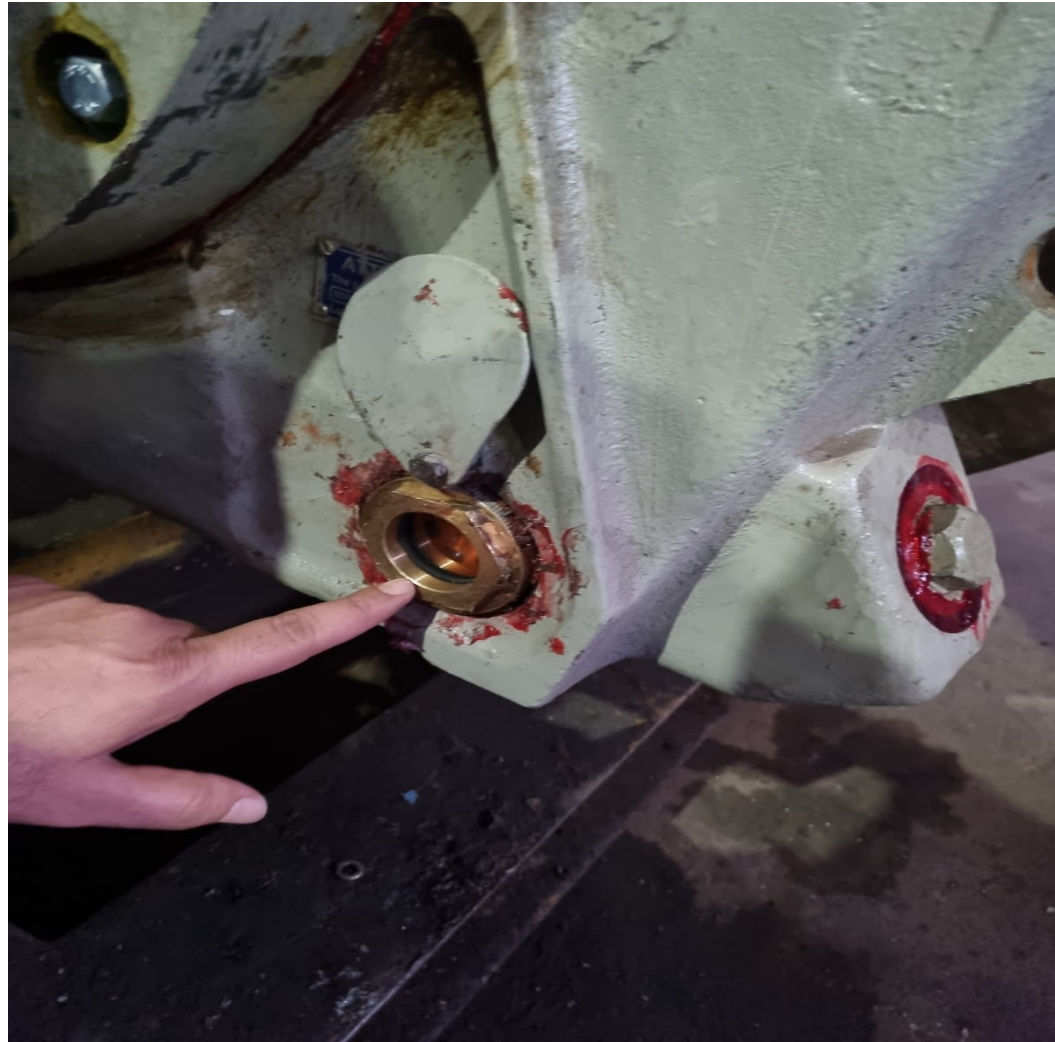
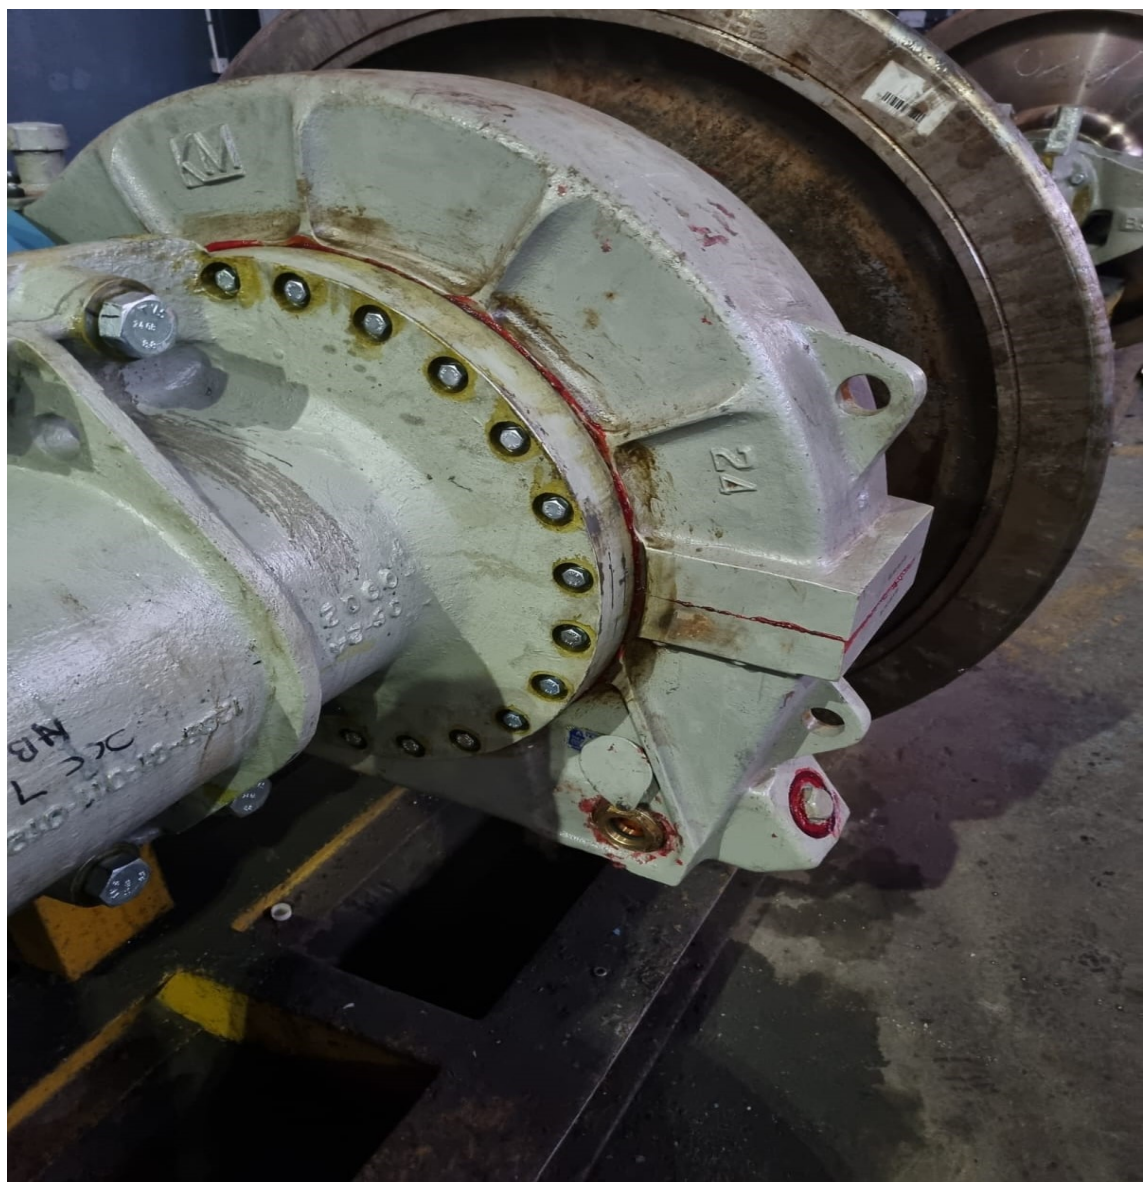
Gear Case Oil Leakage

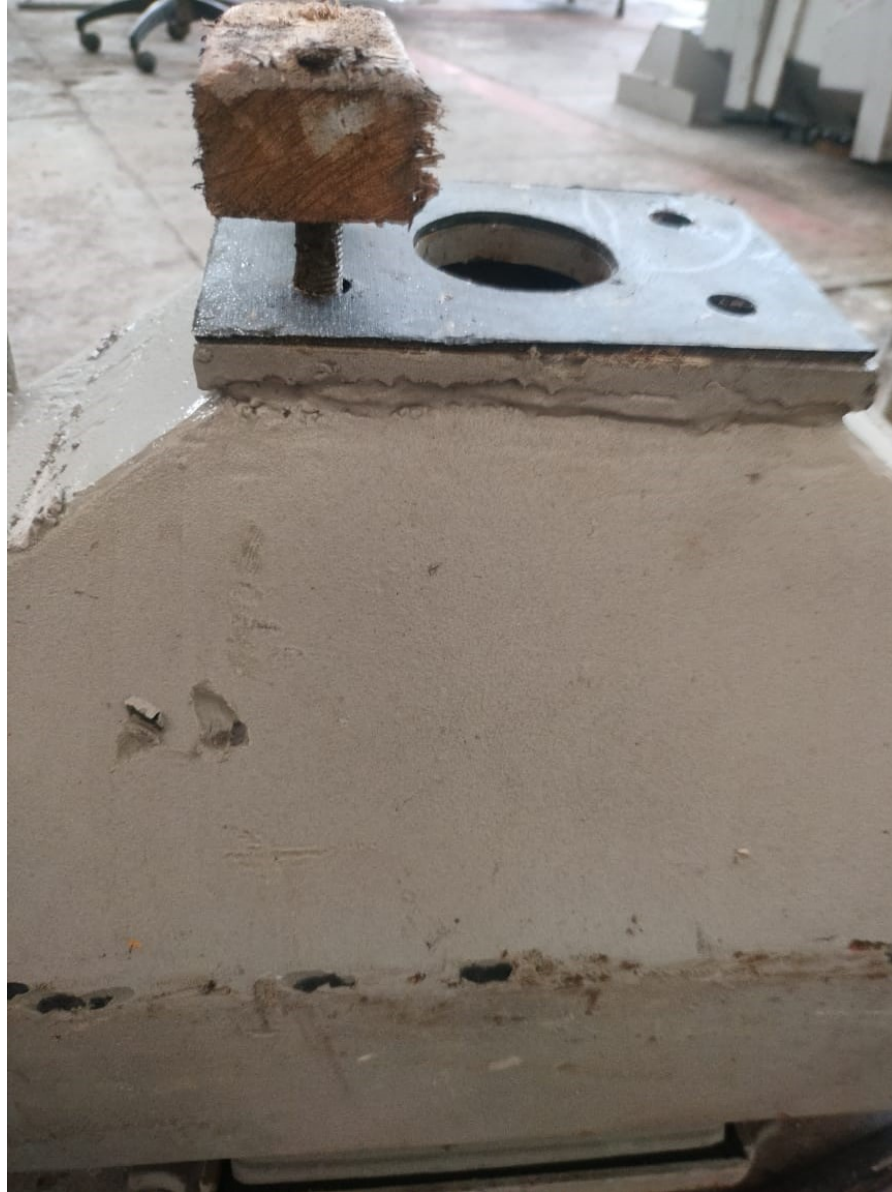
Broken Studs of Sand Box

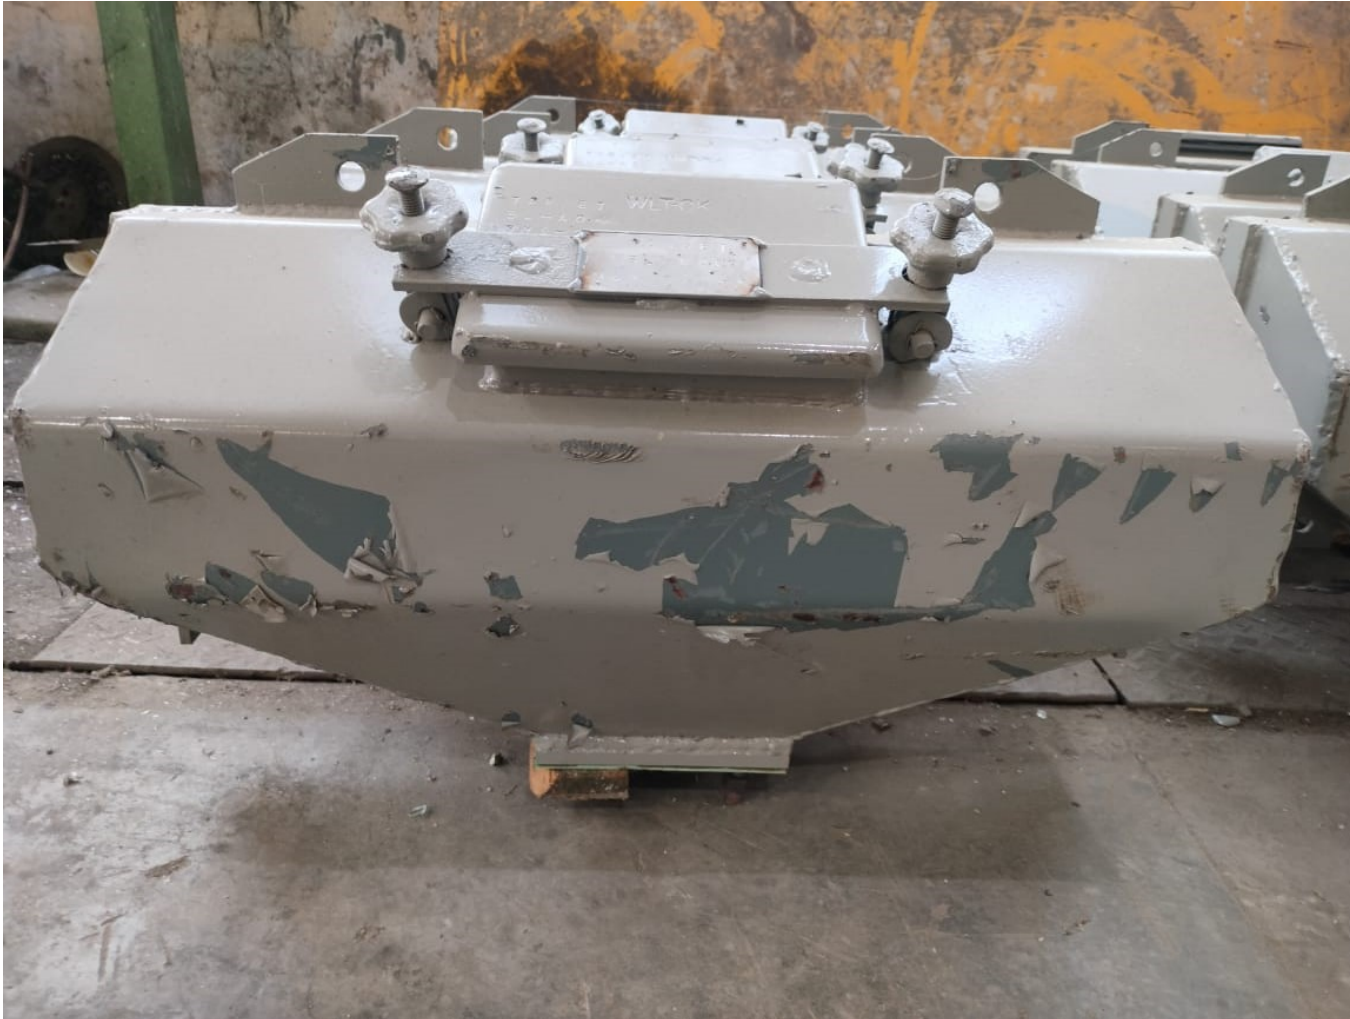
Peeling of Paint from Sand Box

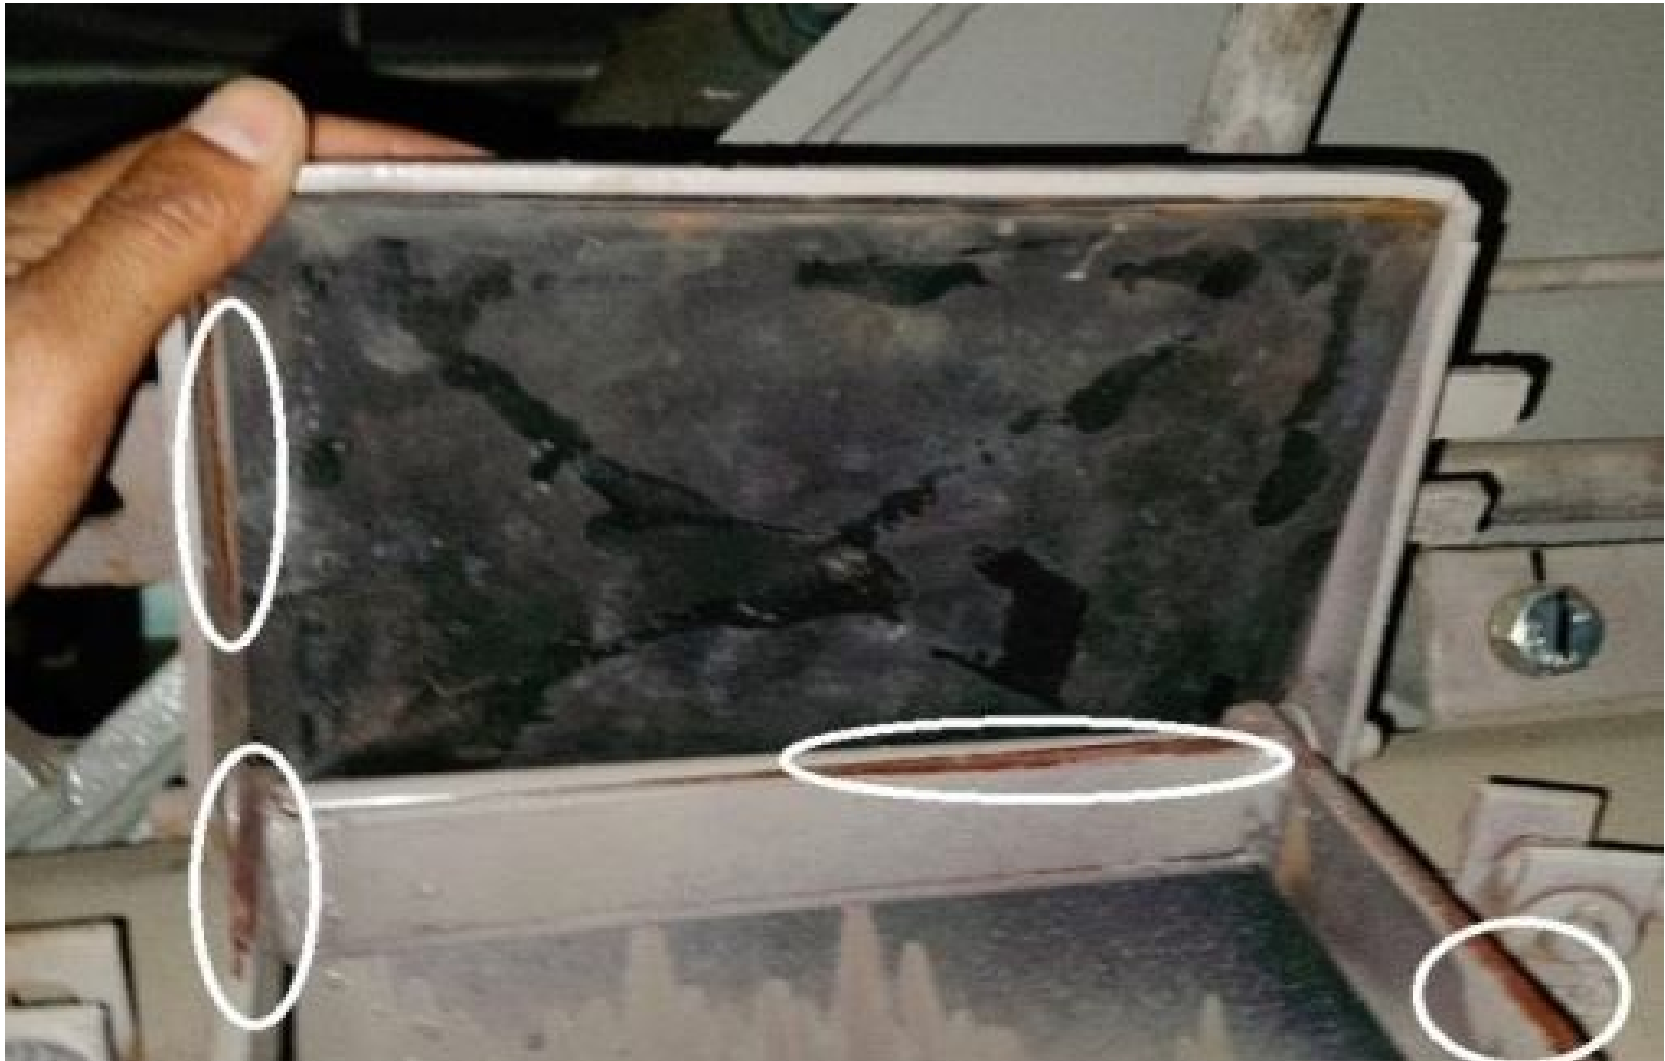
Rusting of Material

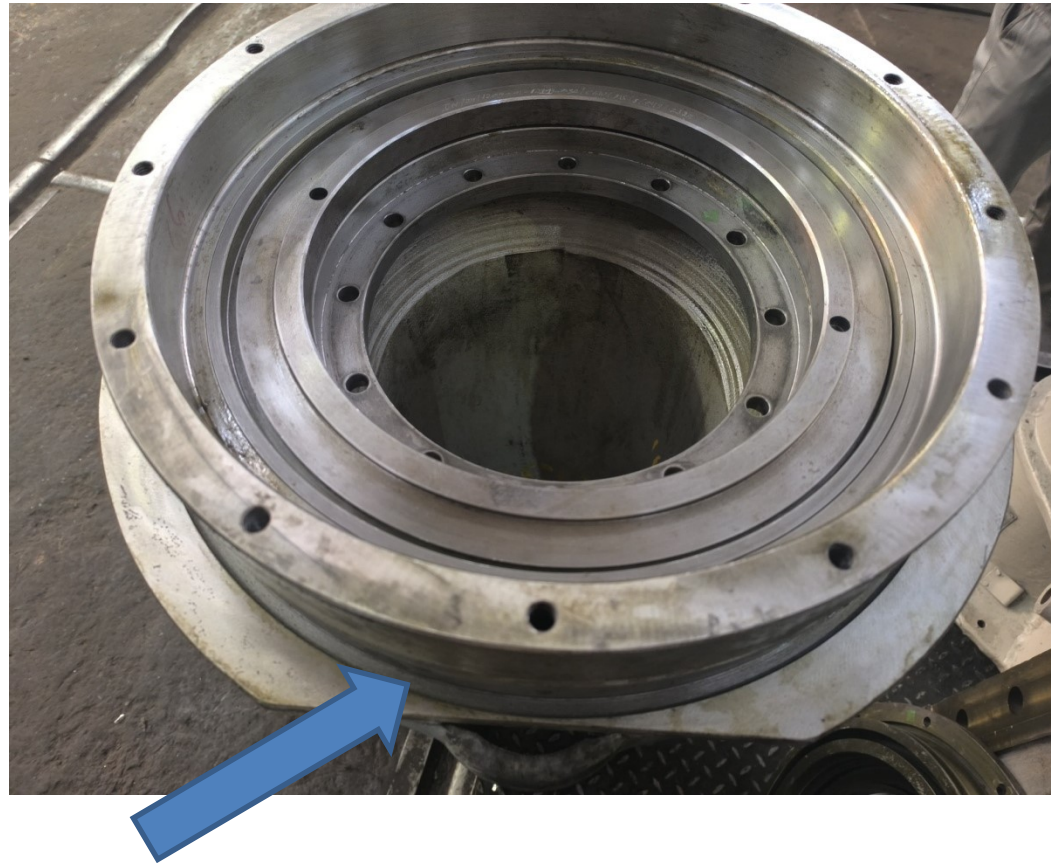
Improper Oil Groove in MSU

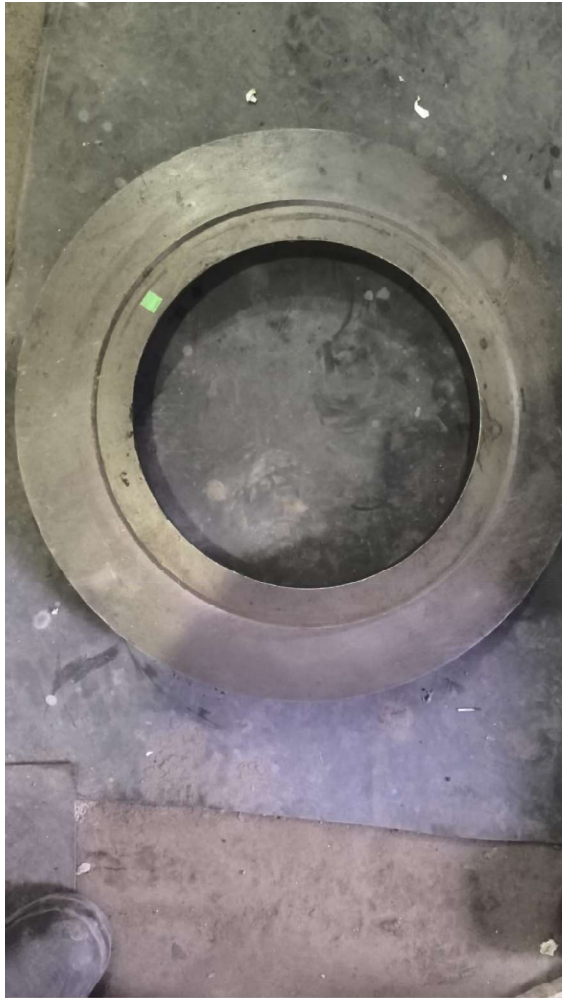
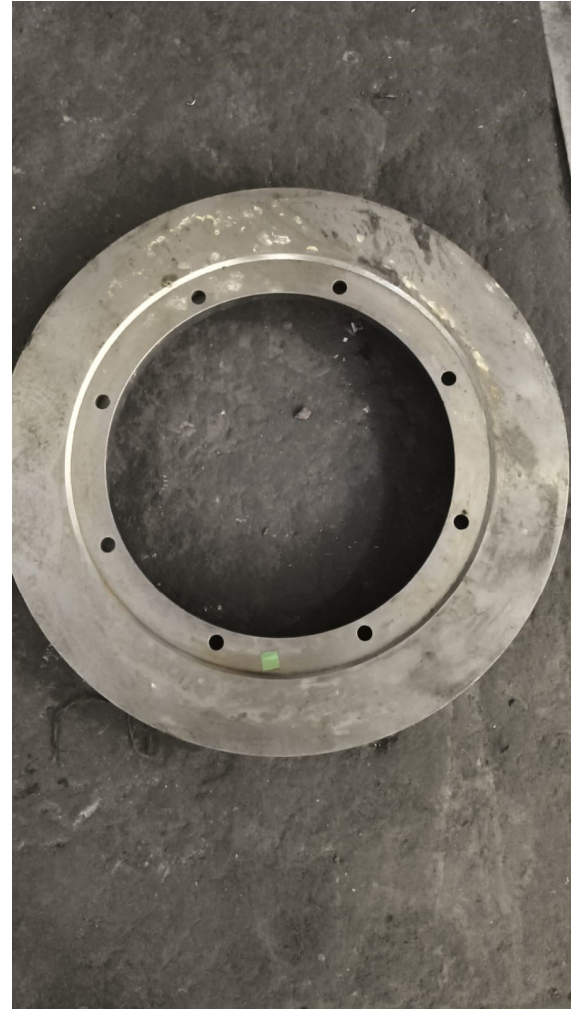
Labyrinth ring without holes

Under Sized 'O' Ring

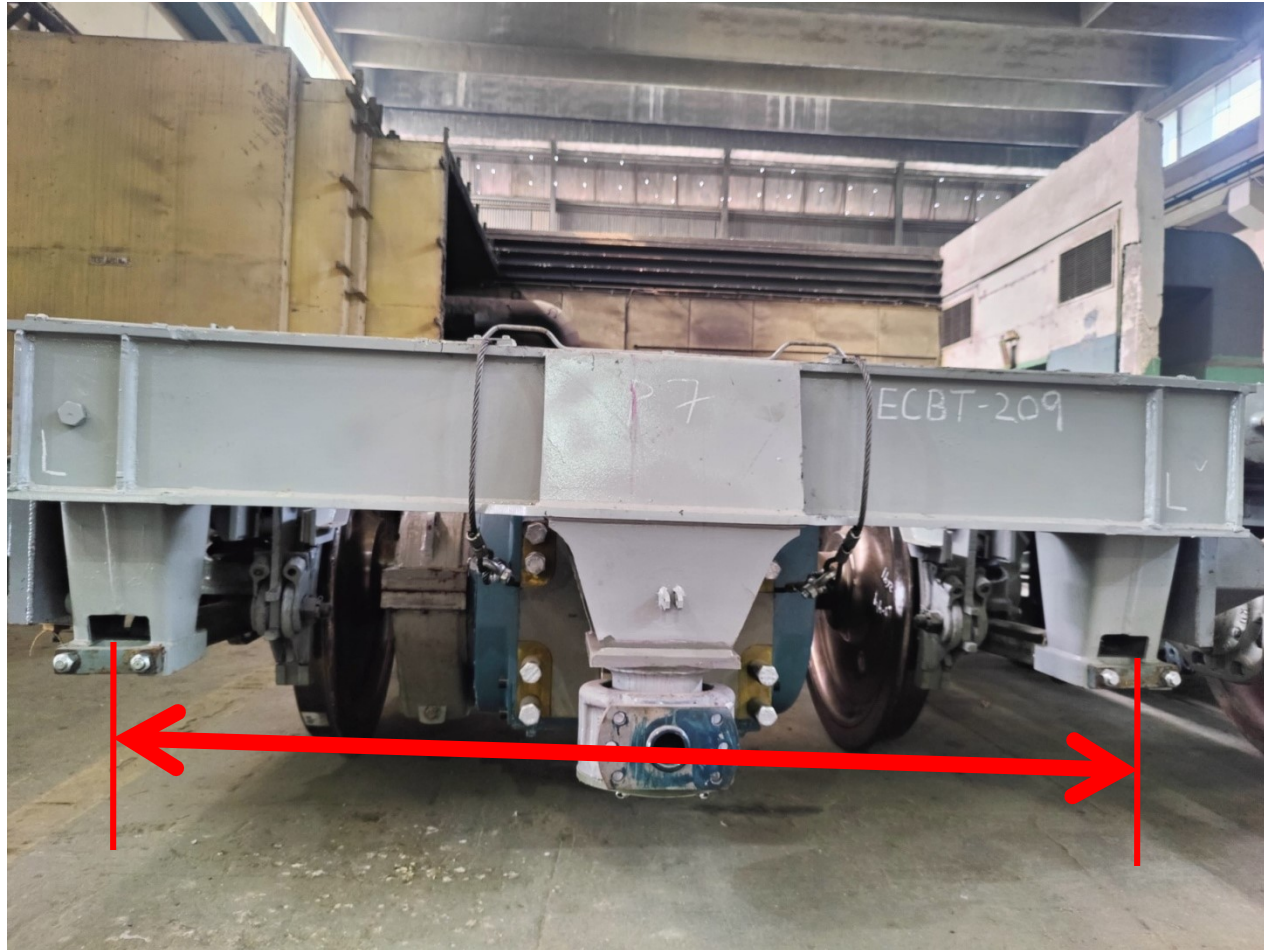
Misalignment of Axle Guide Post
