Various Quality issues in Incoming Material In LA Group of Shops

**Presented by
Dy.CEE/Loco
24.10.2024**

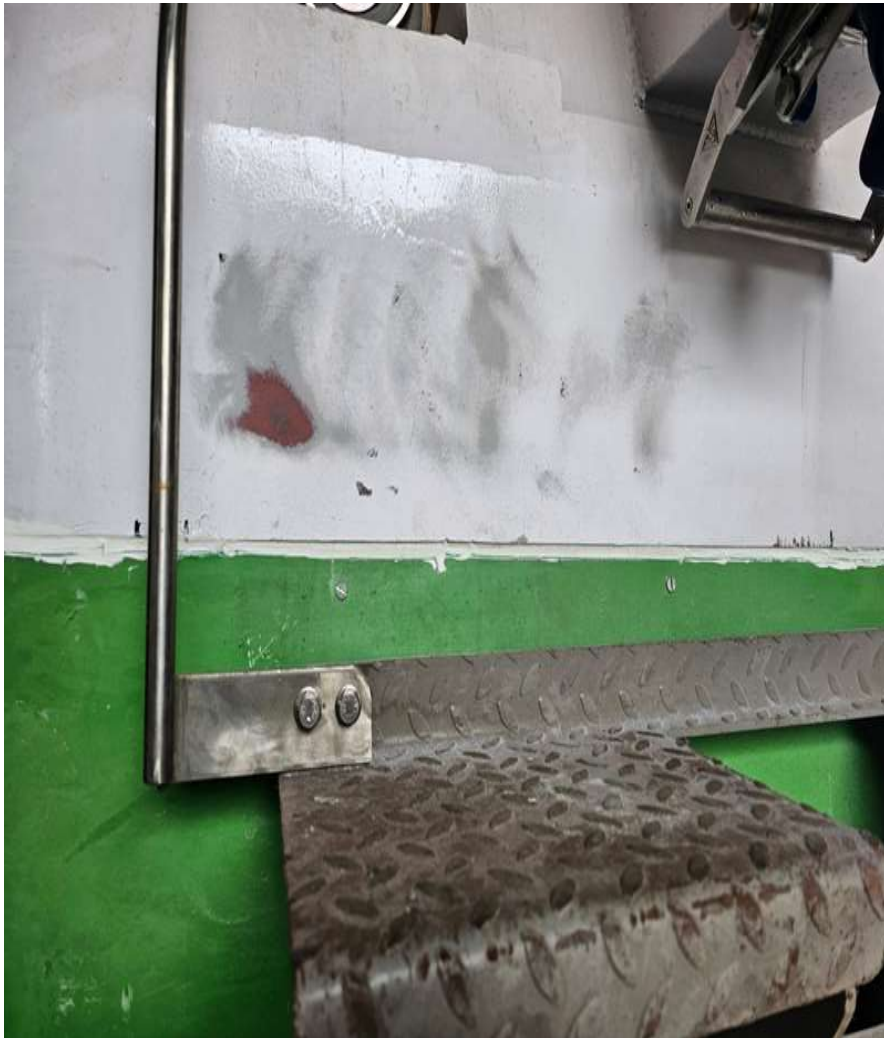
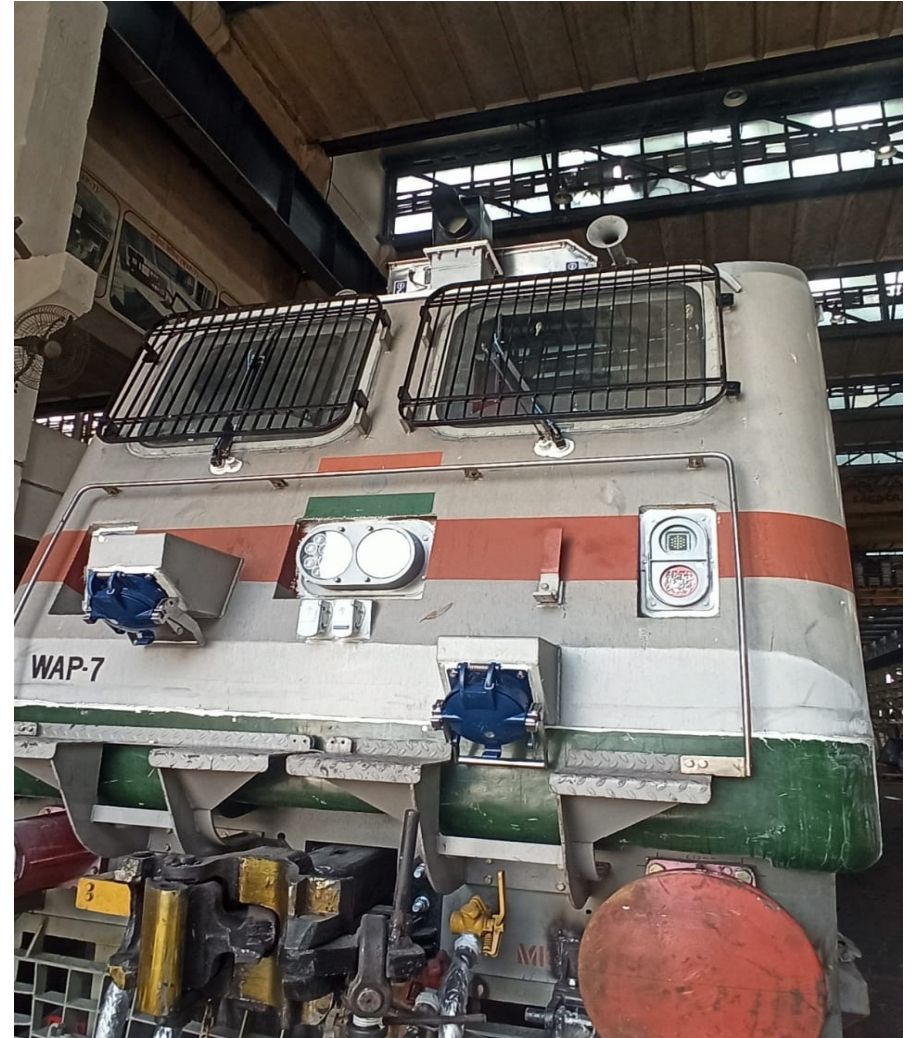
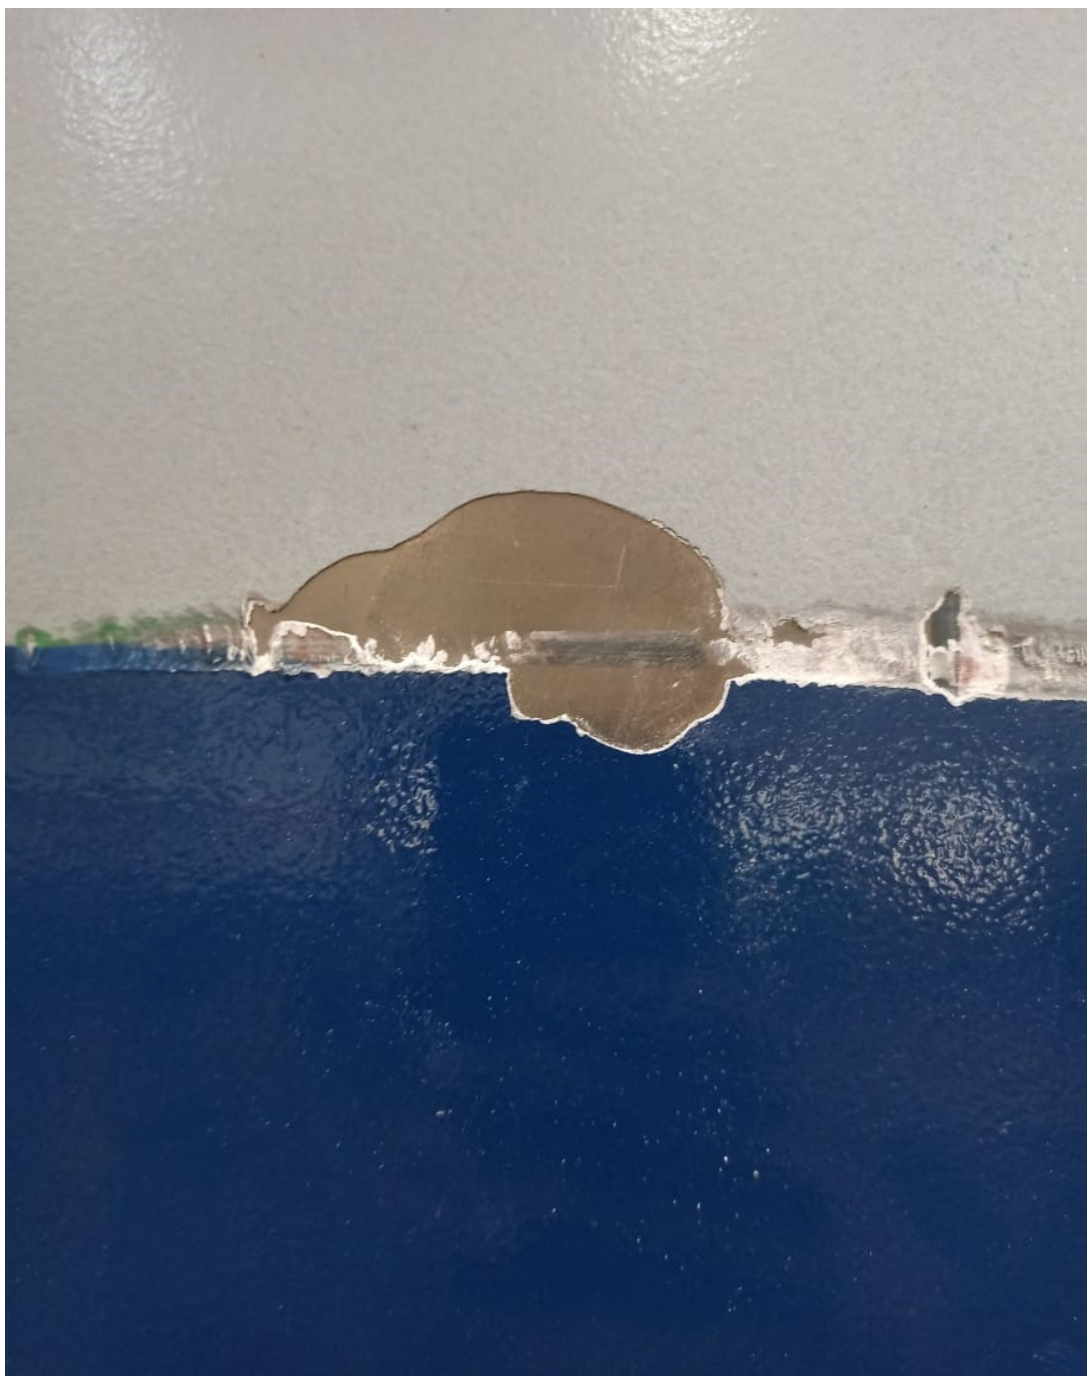
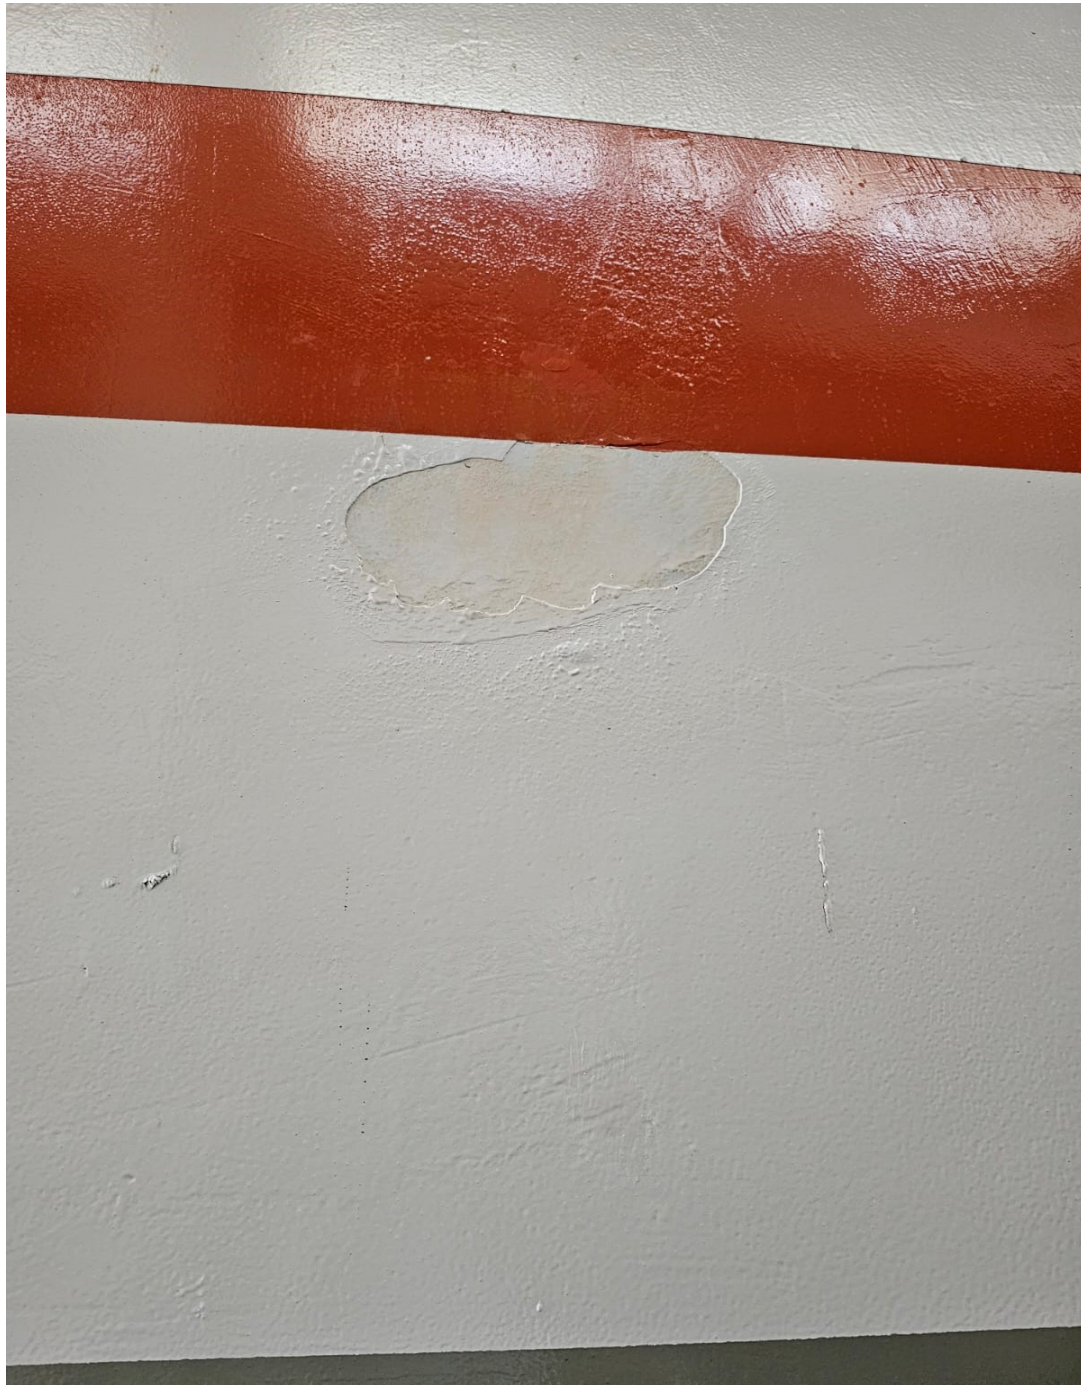
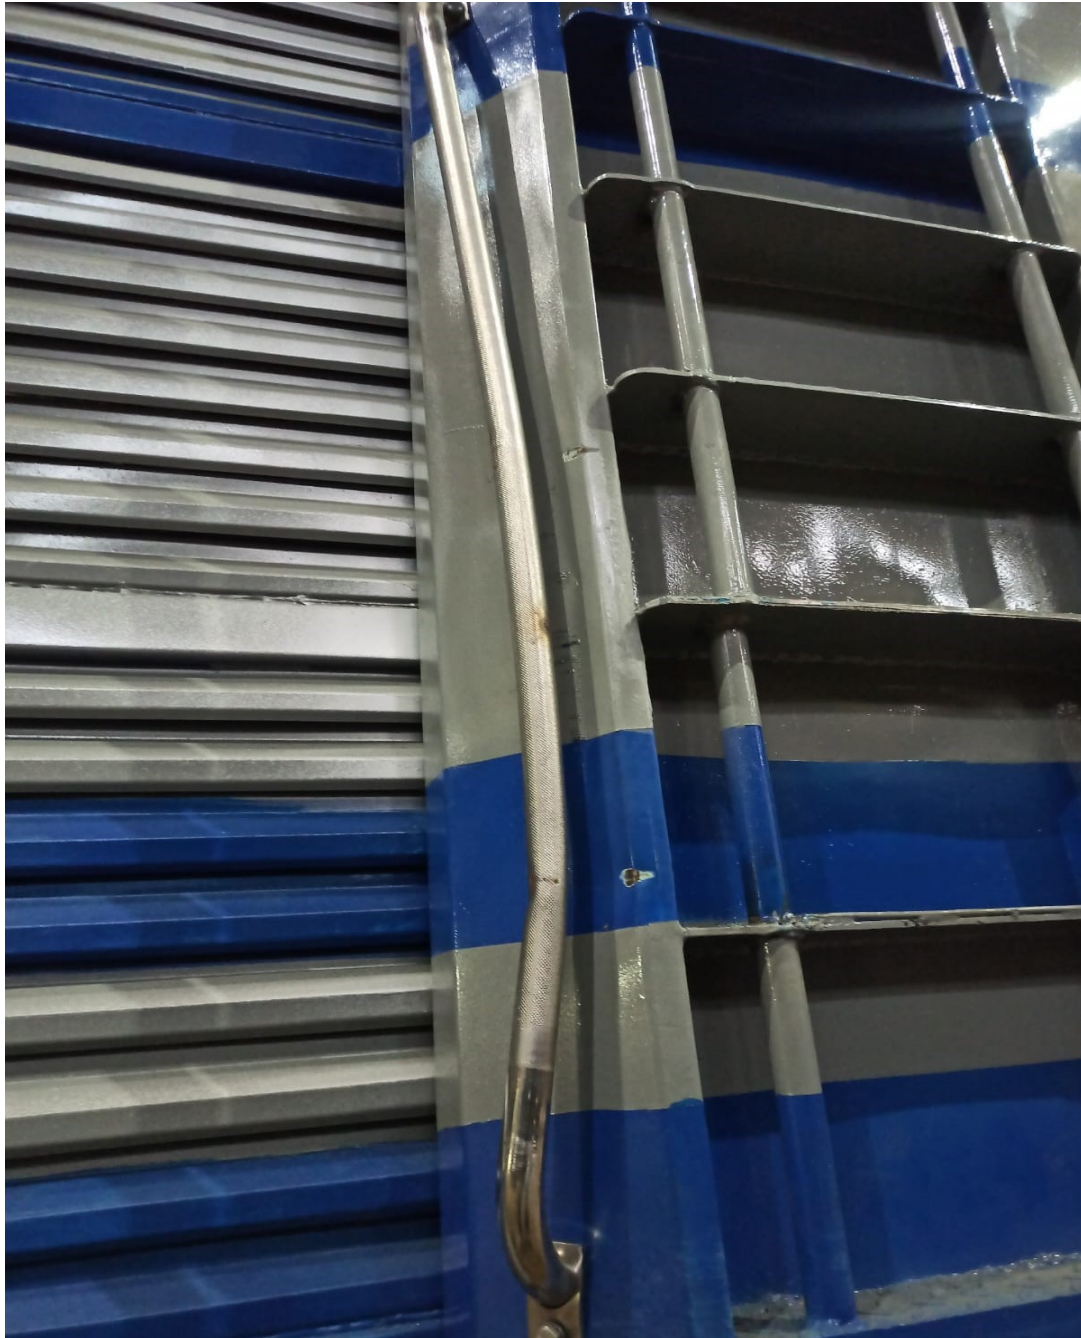
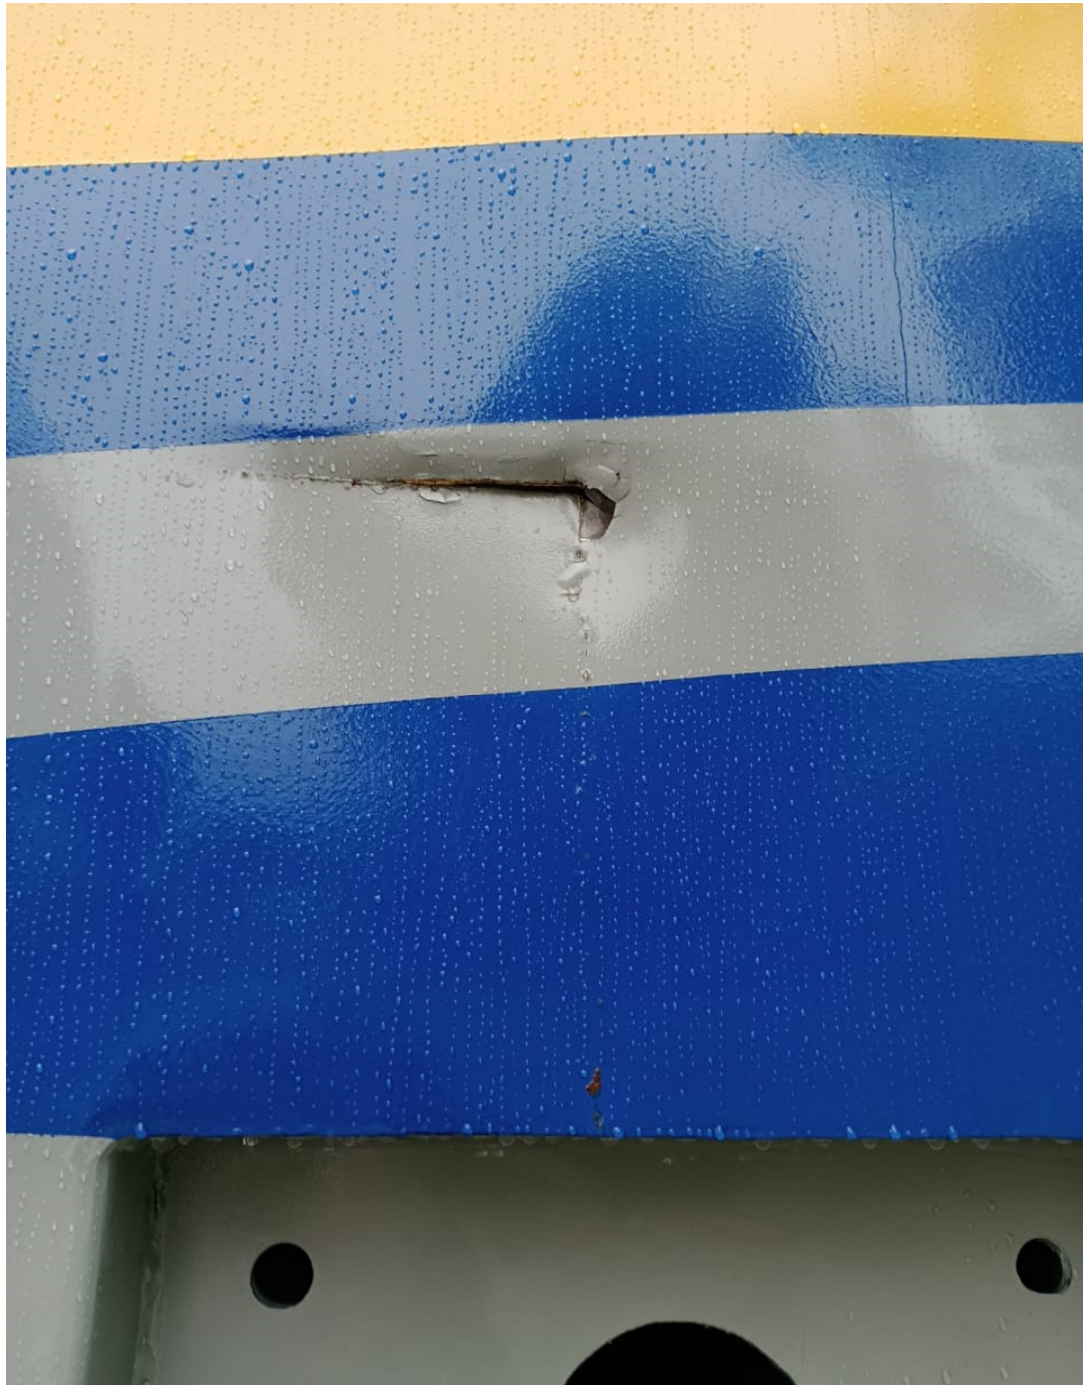
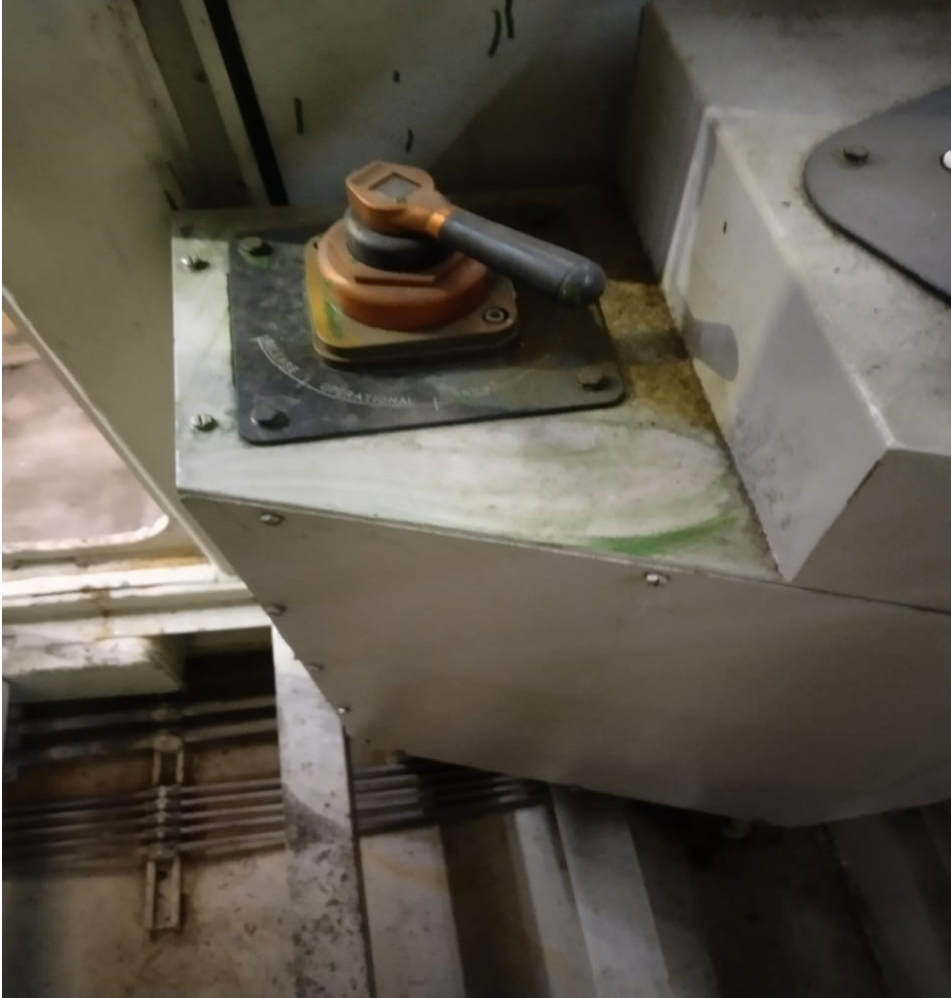
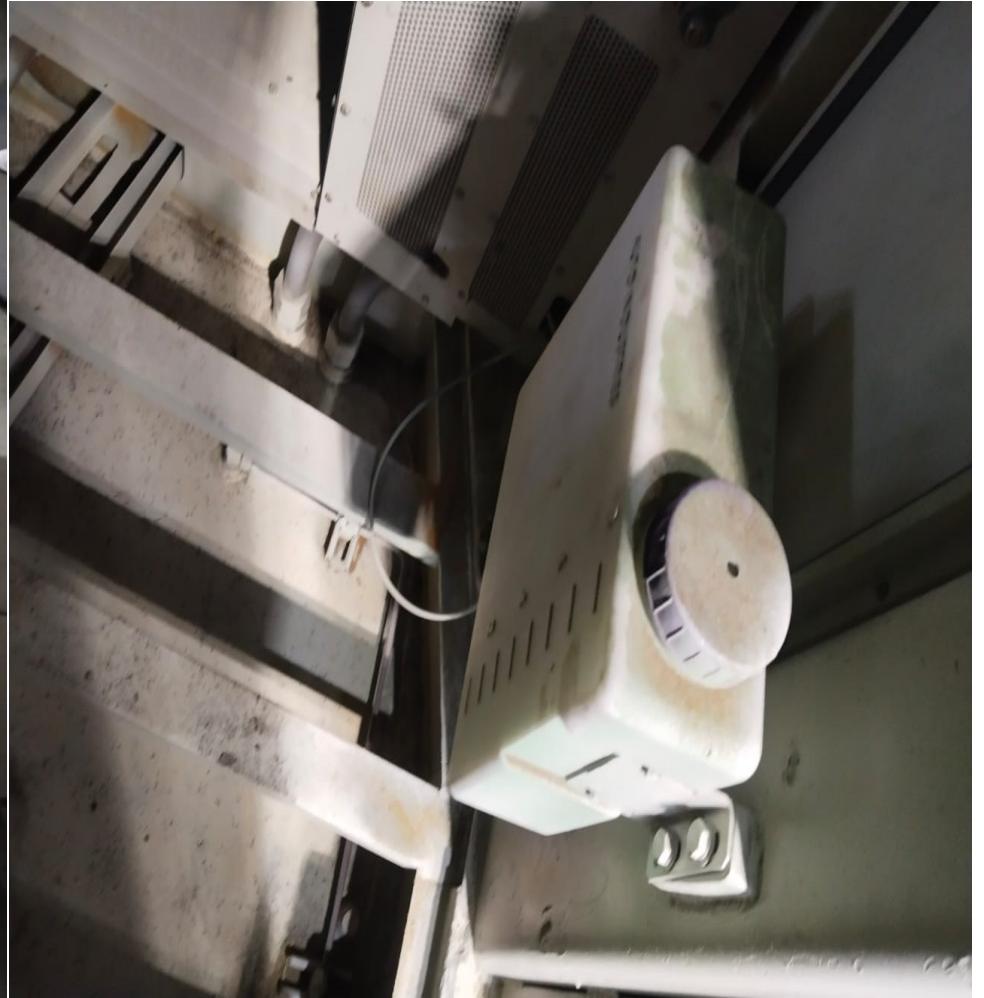
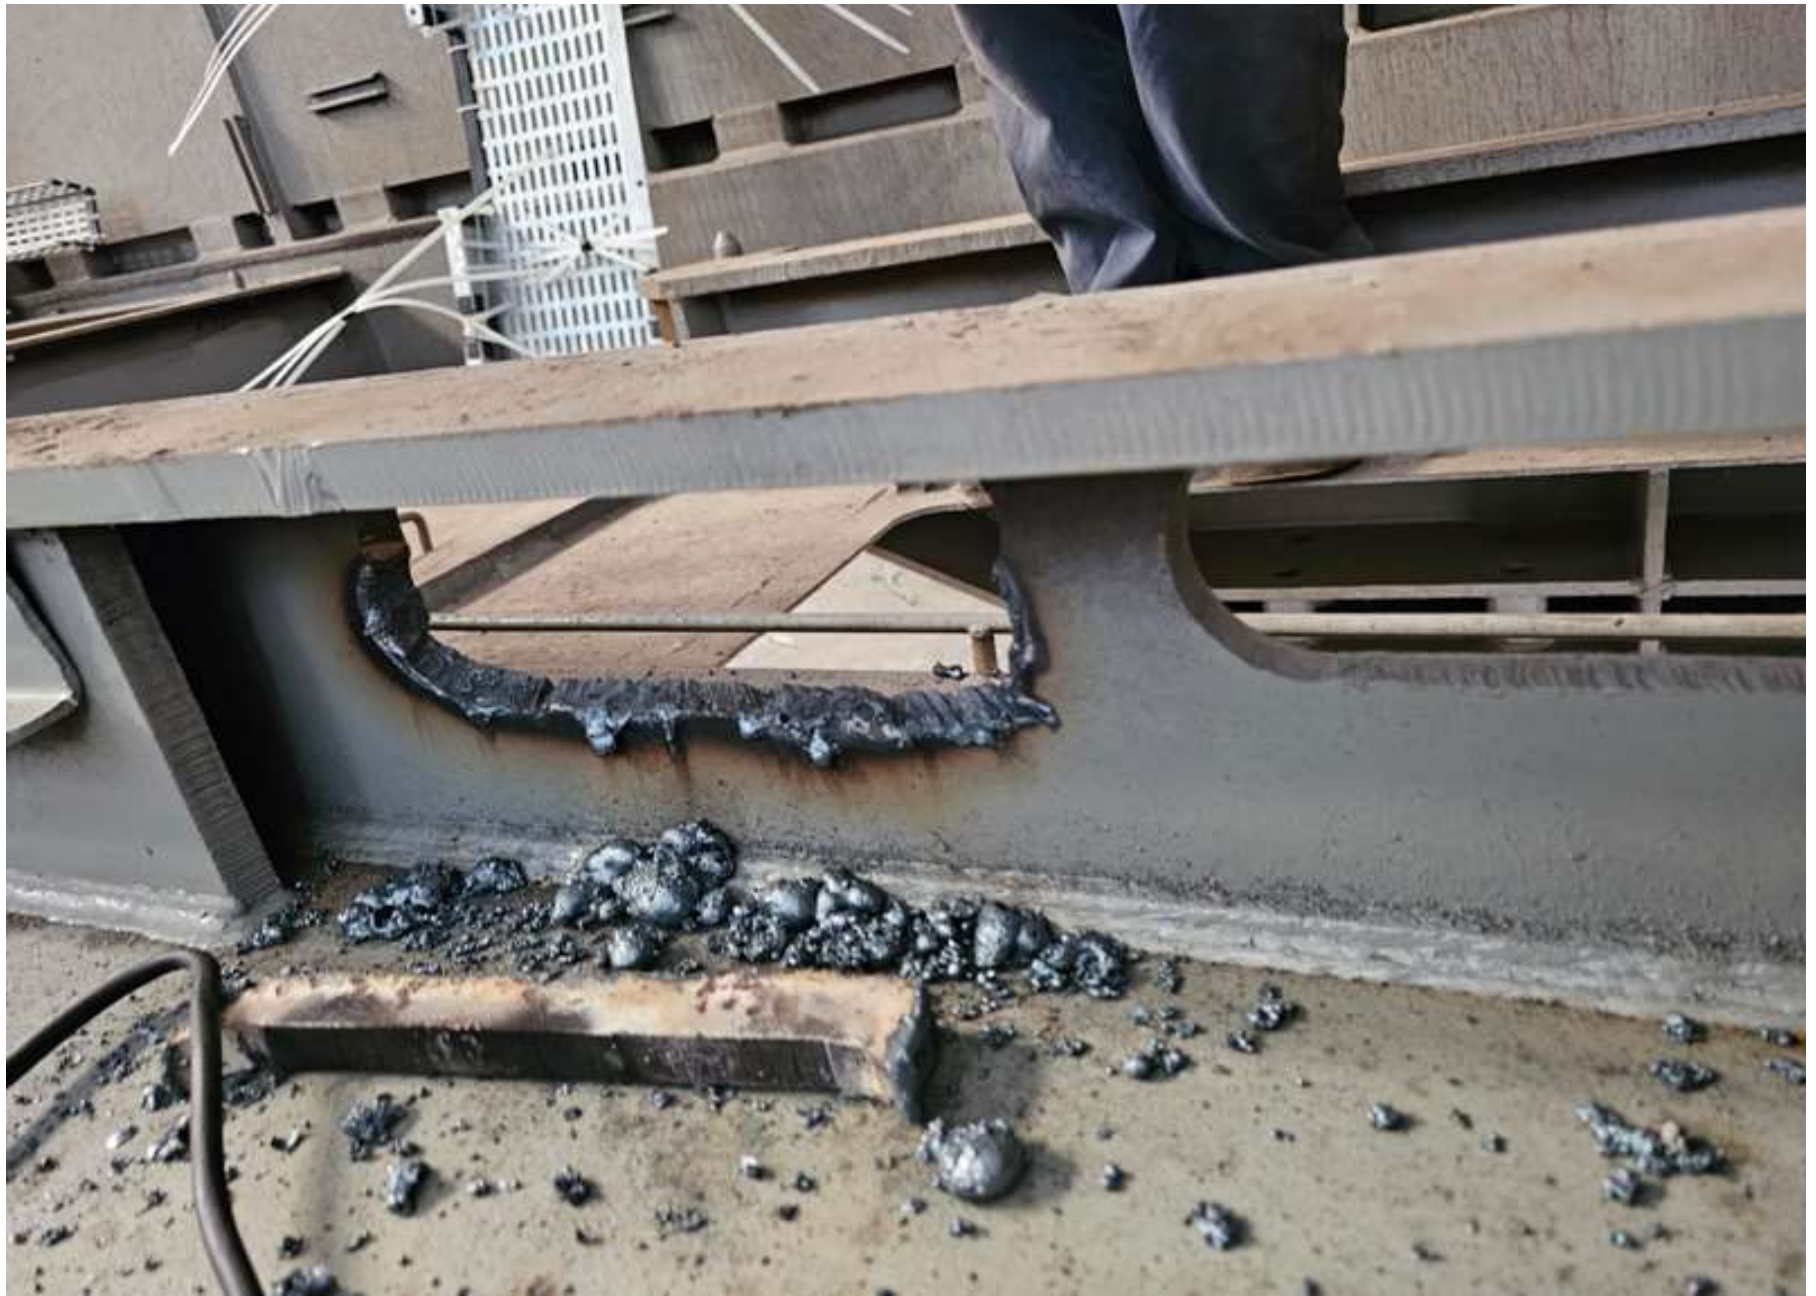
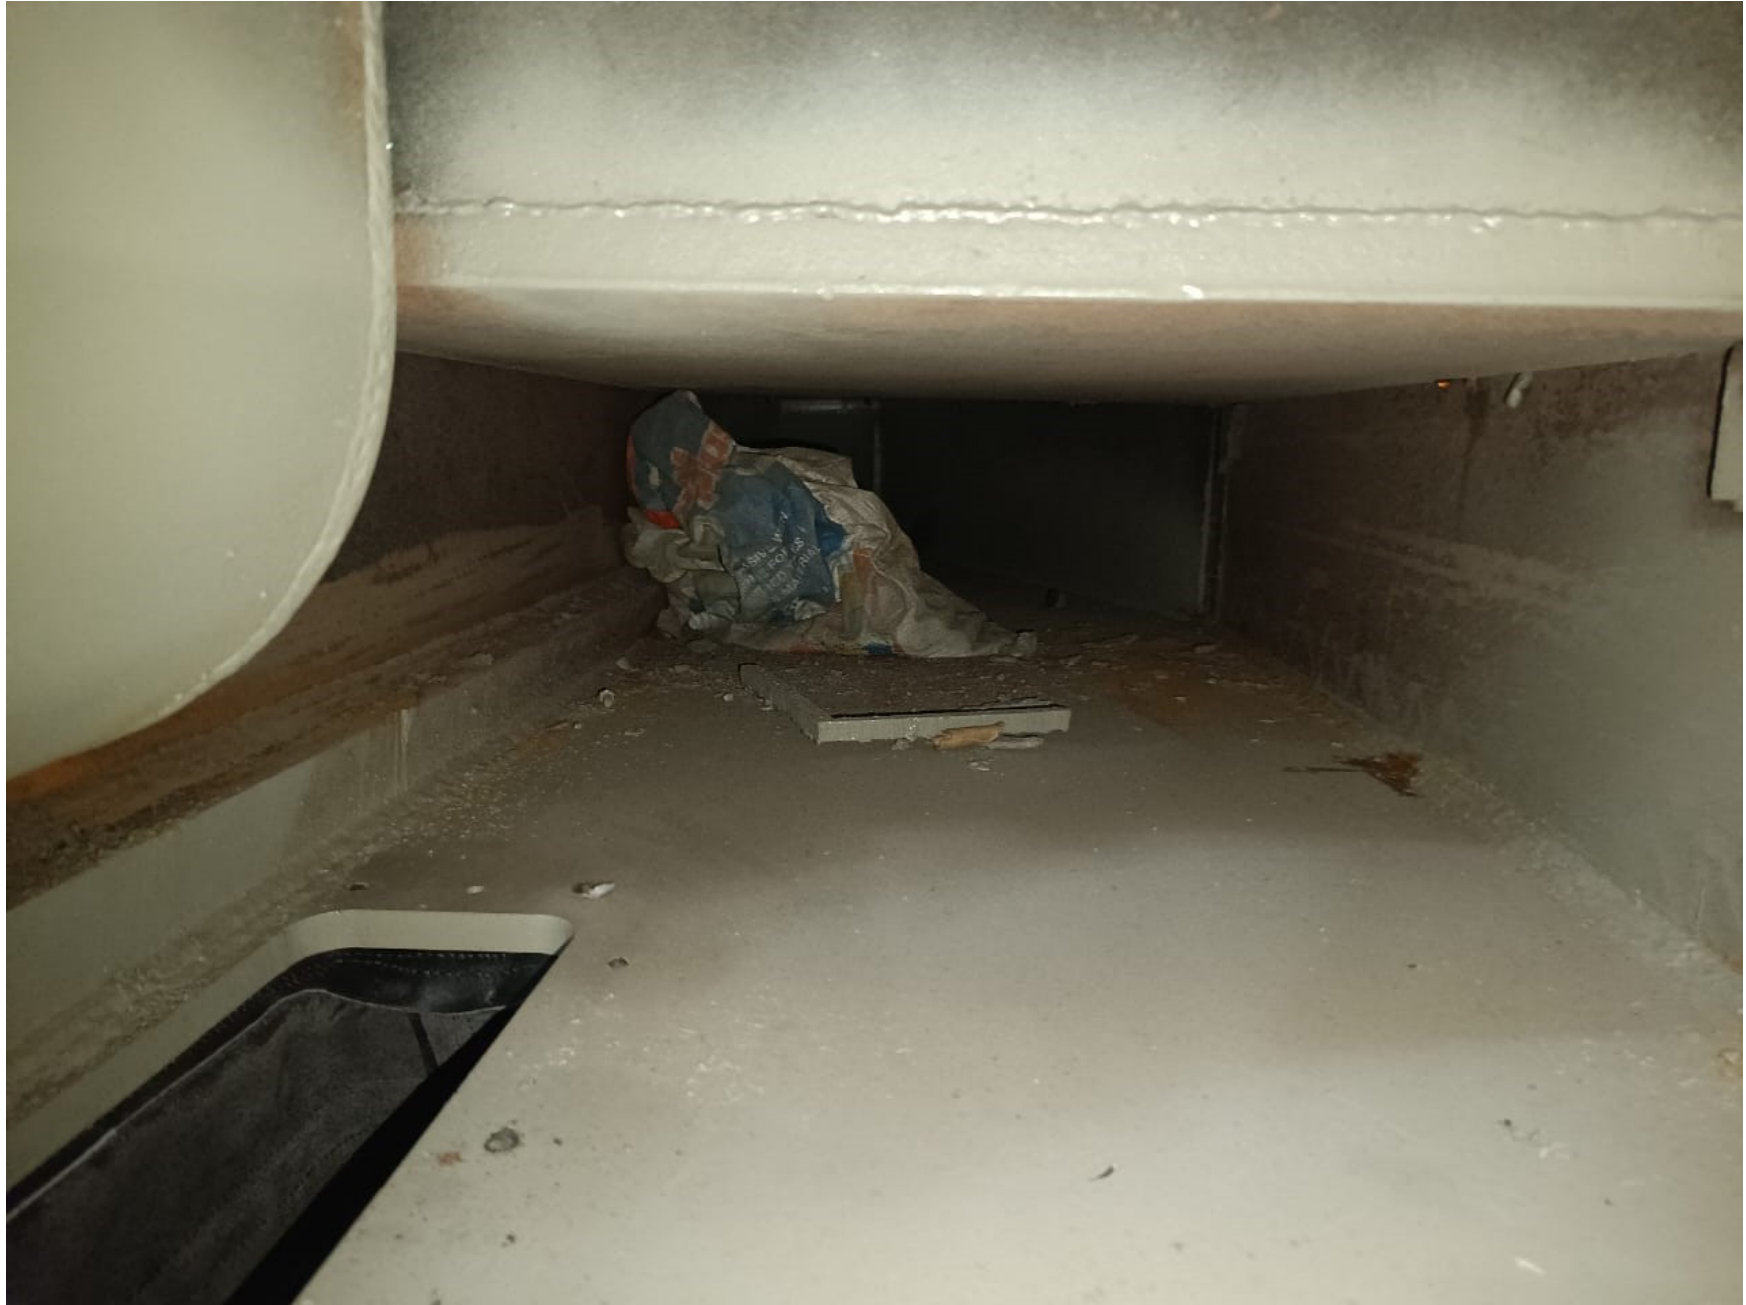
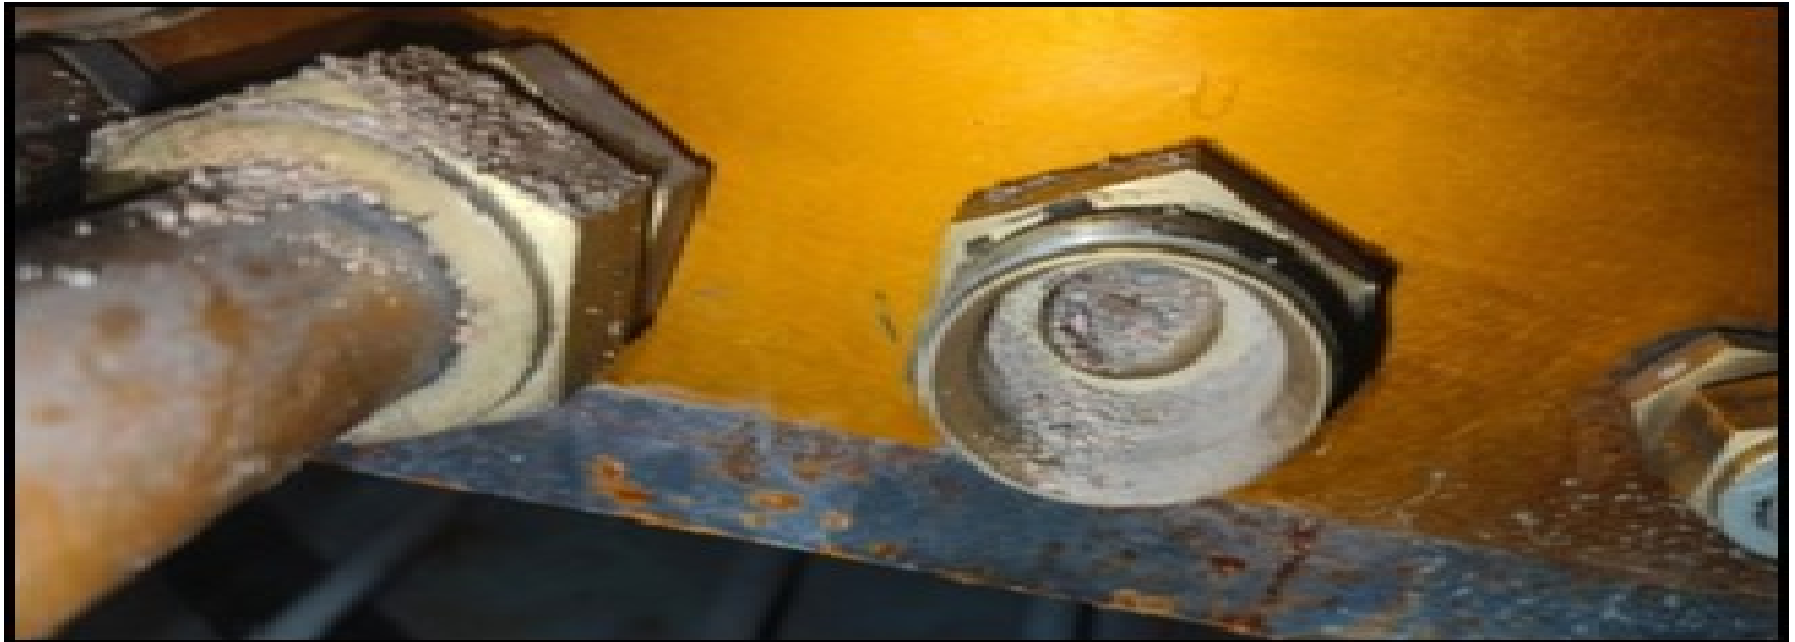
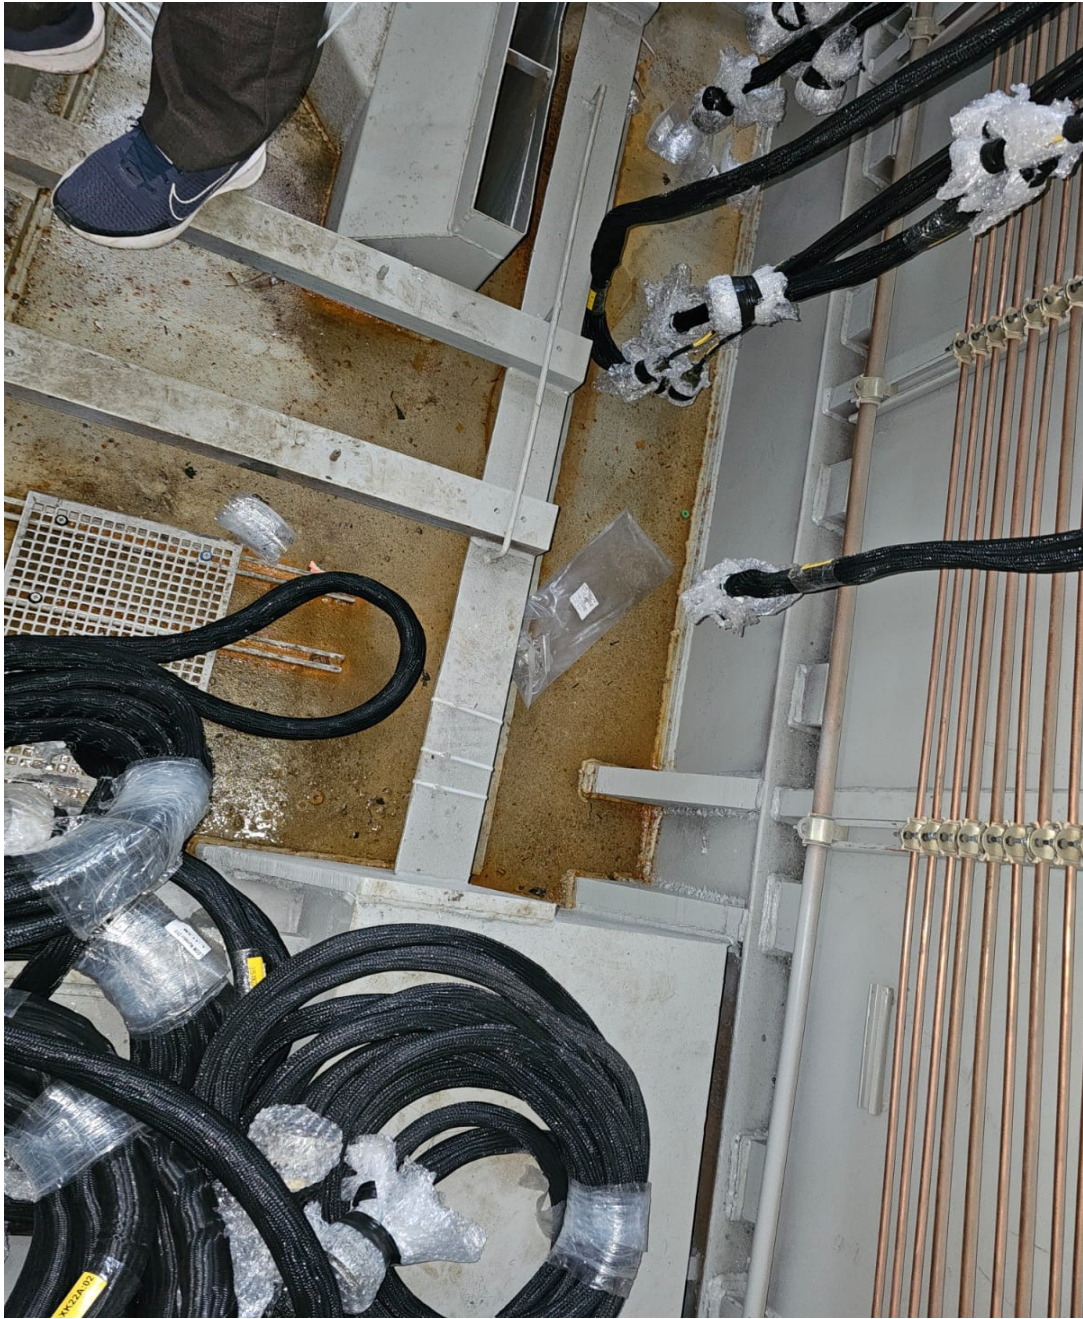
Common Issues faced in Shell

- Poor quality of paint without proper surface cleaning.
- Camber not maintain properly which causes large time in height setting
- Free supply items issued by PLW either wrongly fitted or not fitted
- Poor welding work
- Variation in draft gear collar pocket size.
- Edge finishing not done after cutting.
- Cleaning of pneumatic piping, ducting not done before dispatch.
- Rusted small parts in machine room and underframe.
- Less thickness of underframe mounting legs.
- Water ingress issue

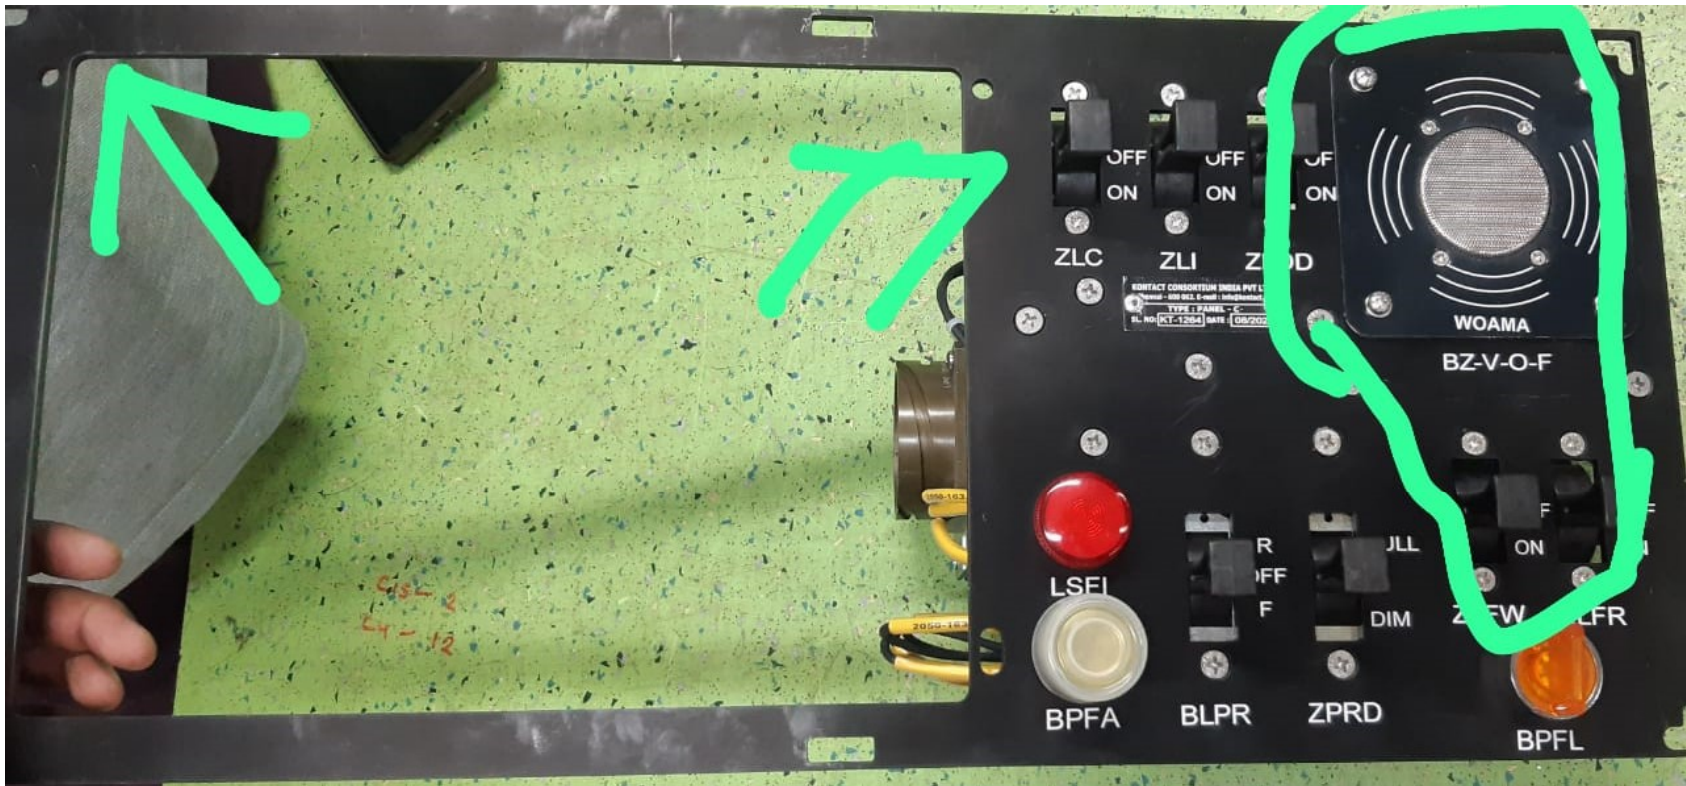
Common Defects in PROPULSION OF WAG-9HC, WAP-7

- Repetitive failure of cards in Aux converter.
- Not availability of spare cards, inverter module, sensors.
- Non standard panel C
- Less trained manpower deployment

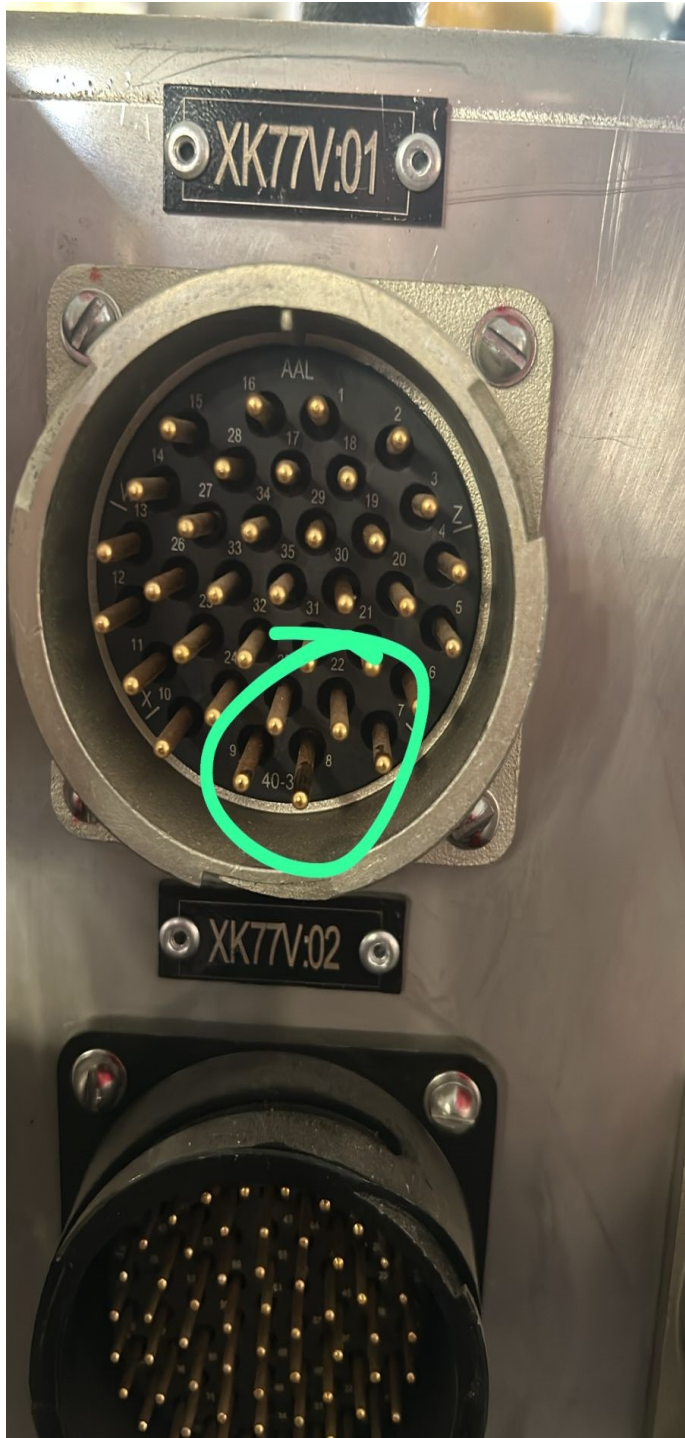
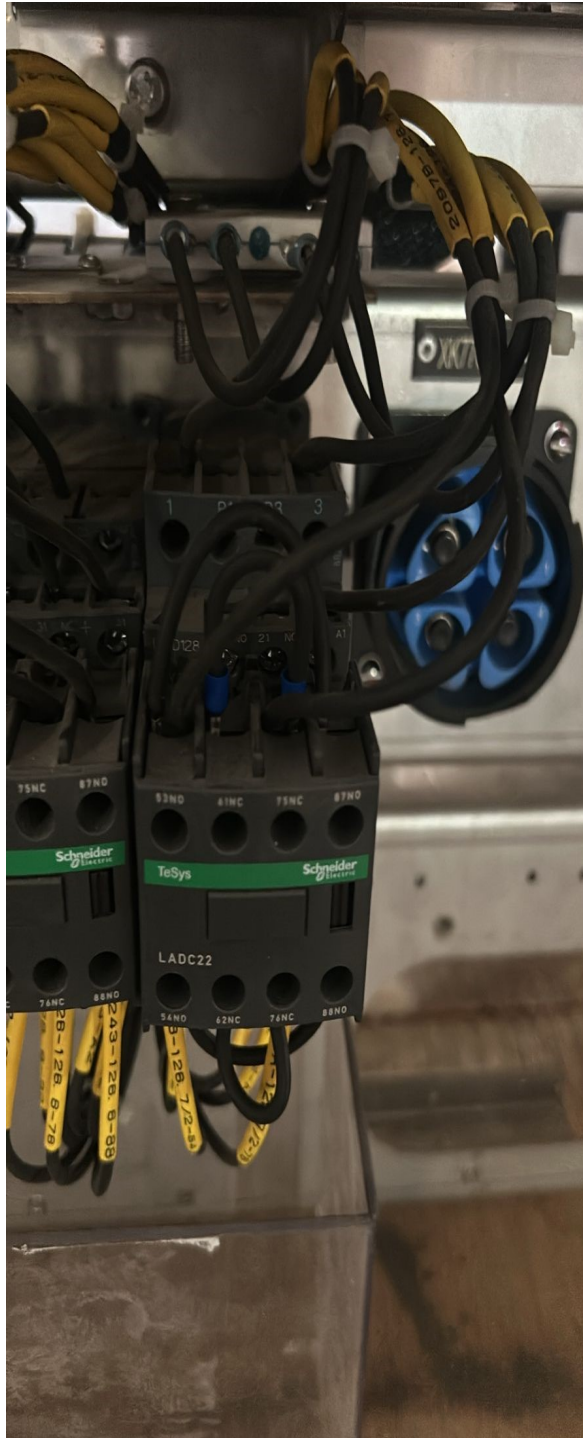
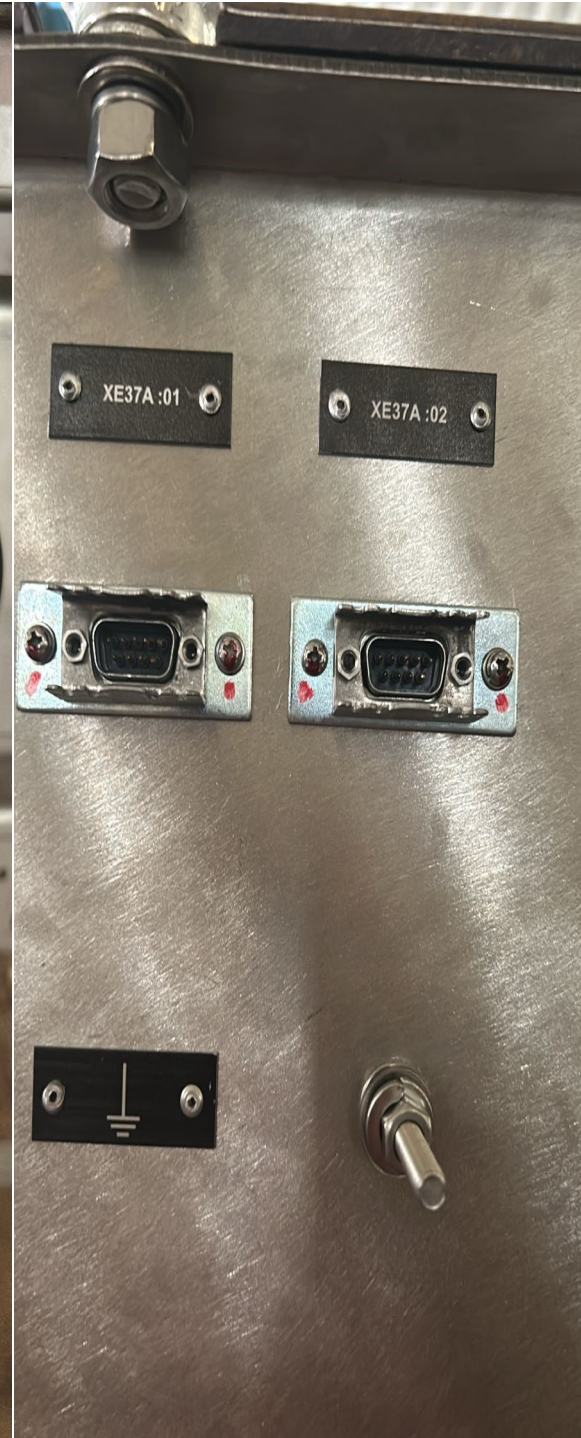
Common Defects in SB1, SB2, HB1, HB2 PANELS & FILTER CUBICLE SUPPLIERS

- Loose connections
- Poor crimping
- Loop provided with Wrong or no marking of wires
- Door lock missing
- Mounting bolts problem.
- Material not supplied as per Spec/MS attached in PO.
- Non-availability of spare items.
- Deviation in sub-items make from approved BoM.
