Various Quality issues in Incoming Material In LA Group of Shops

**Presented by
Dy.CEE/Loco
24.10.2024**

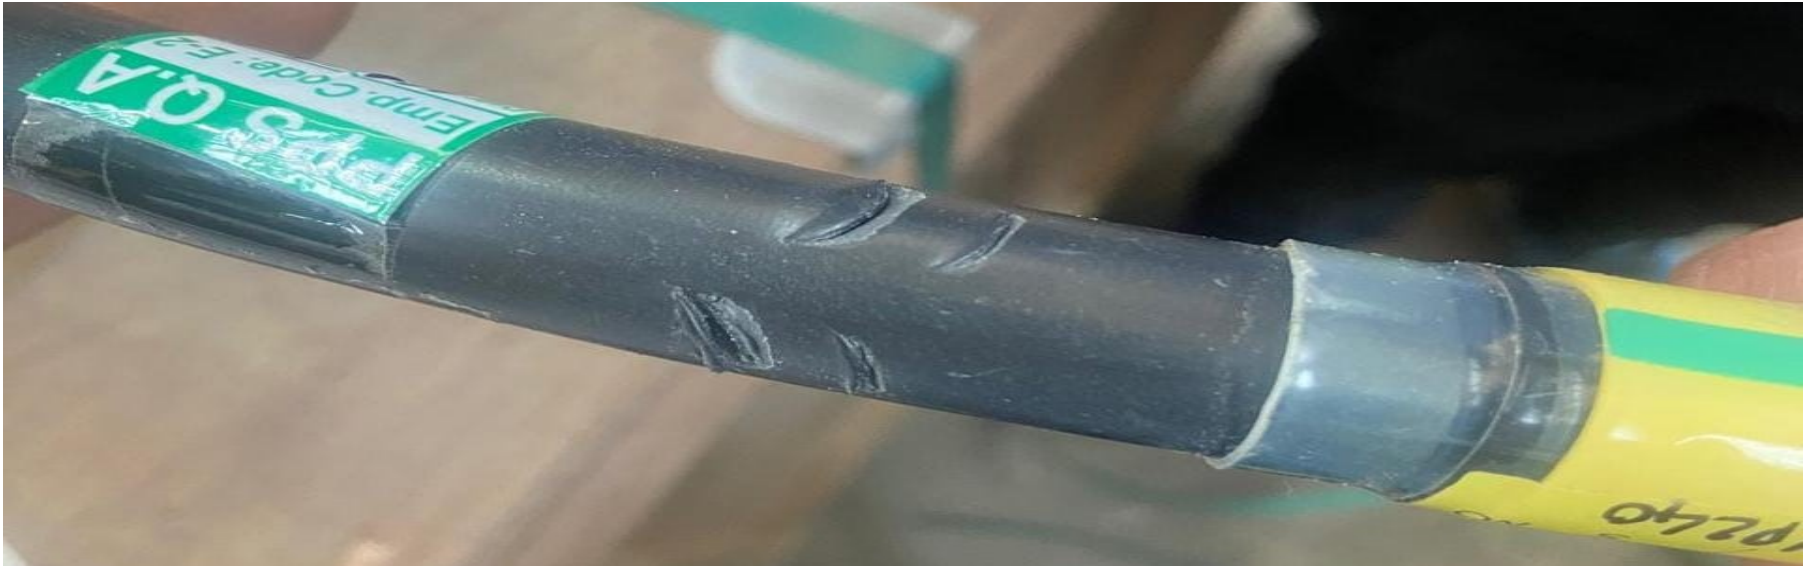
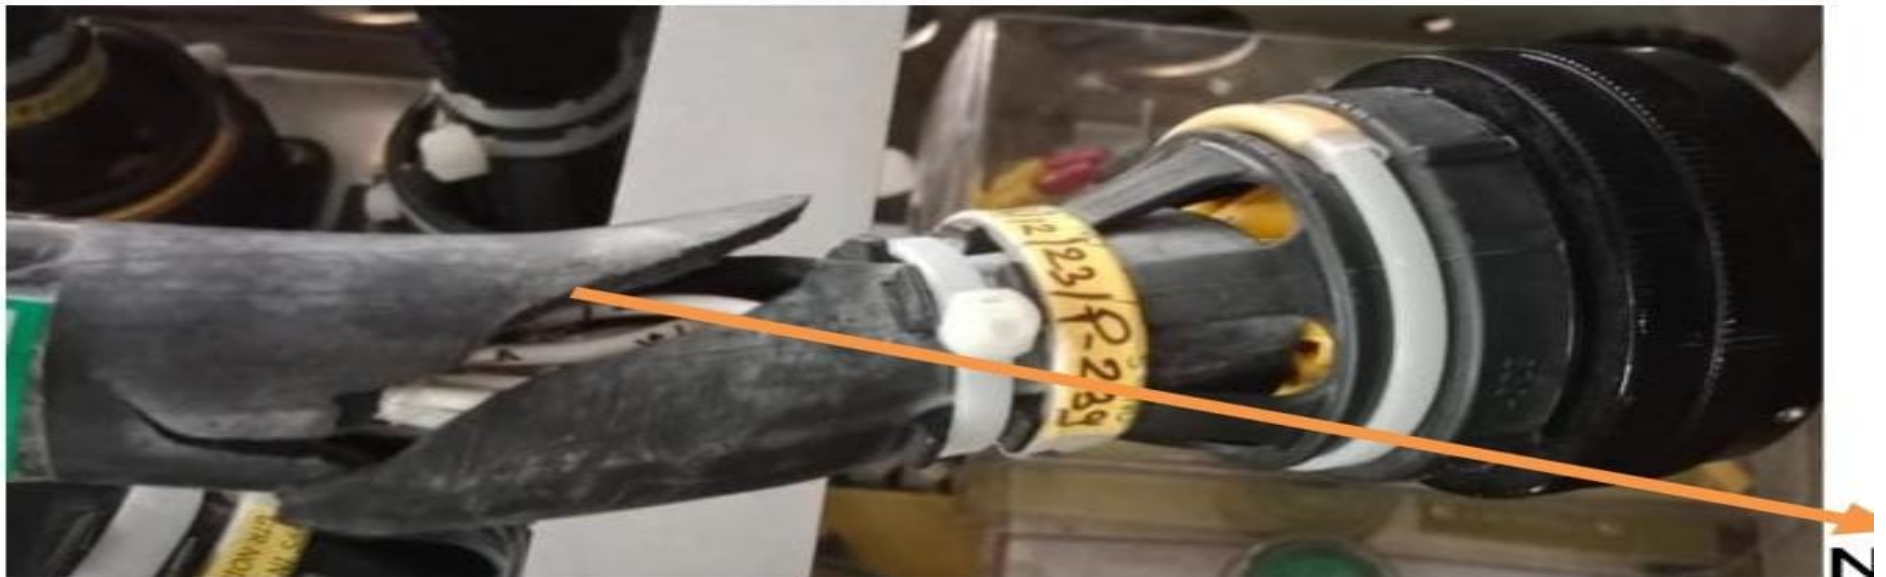
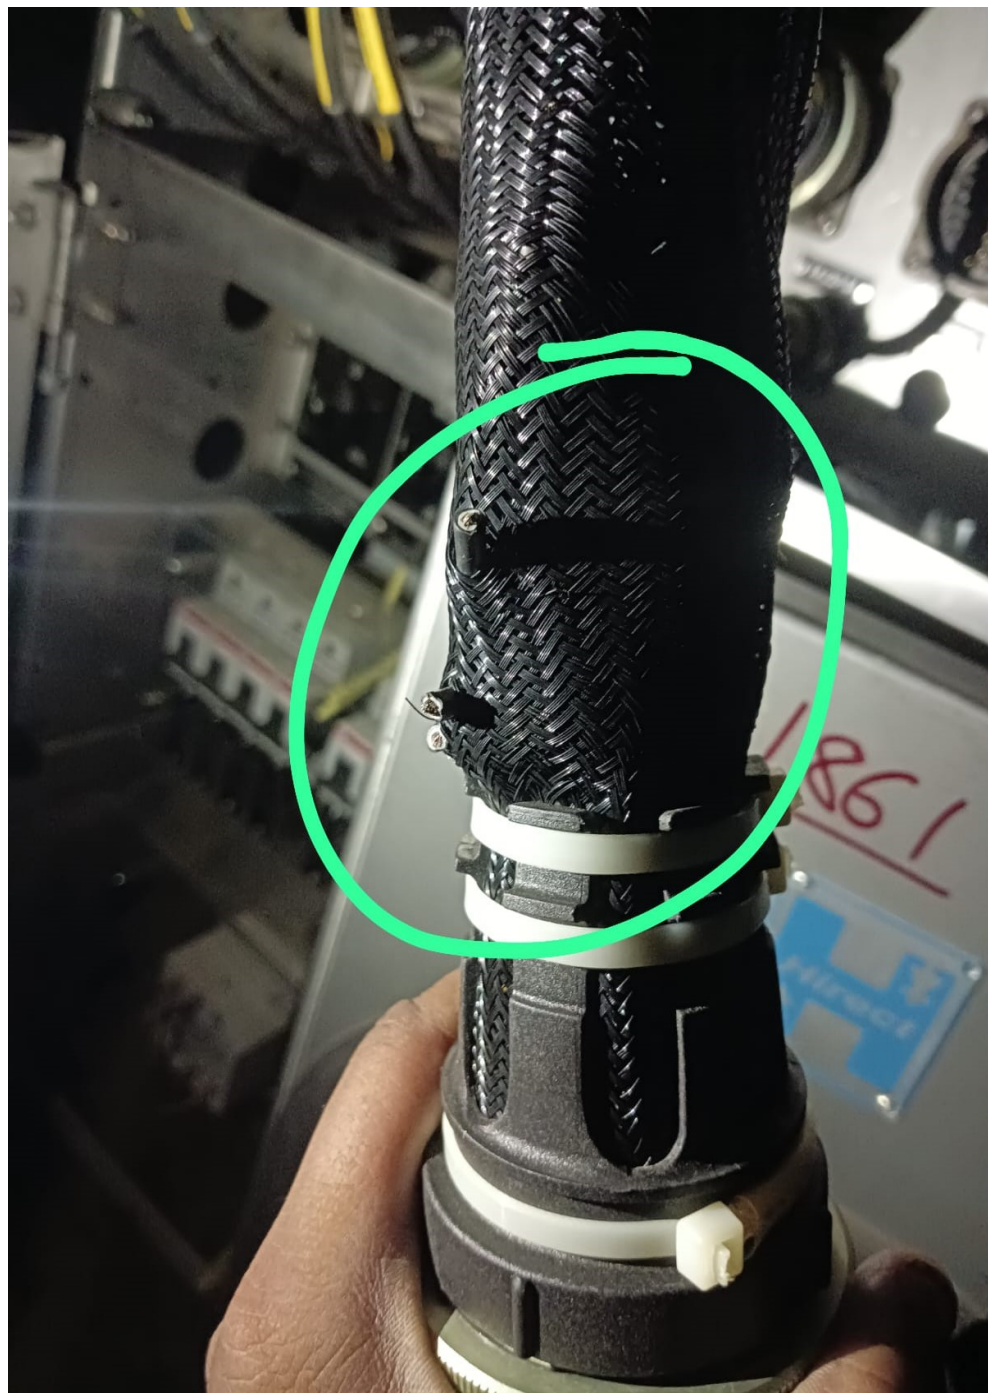
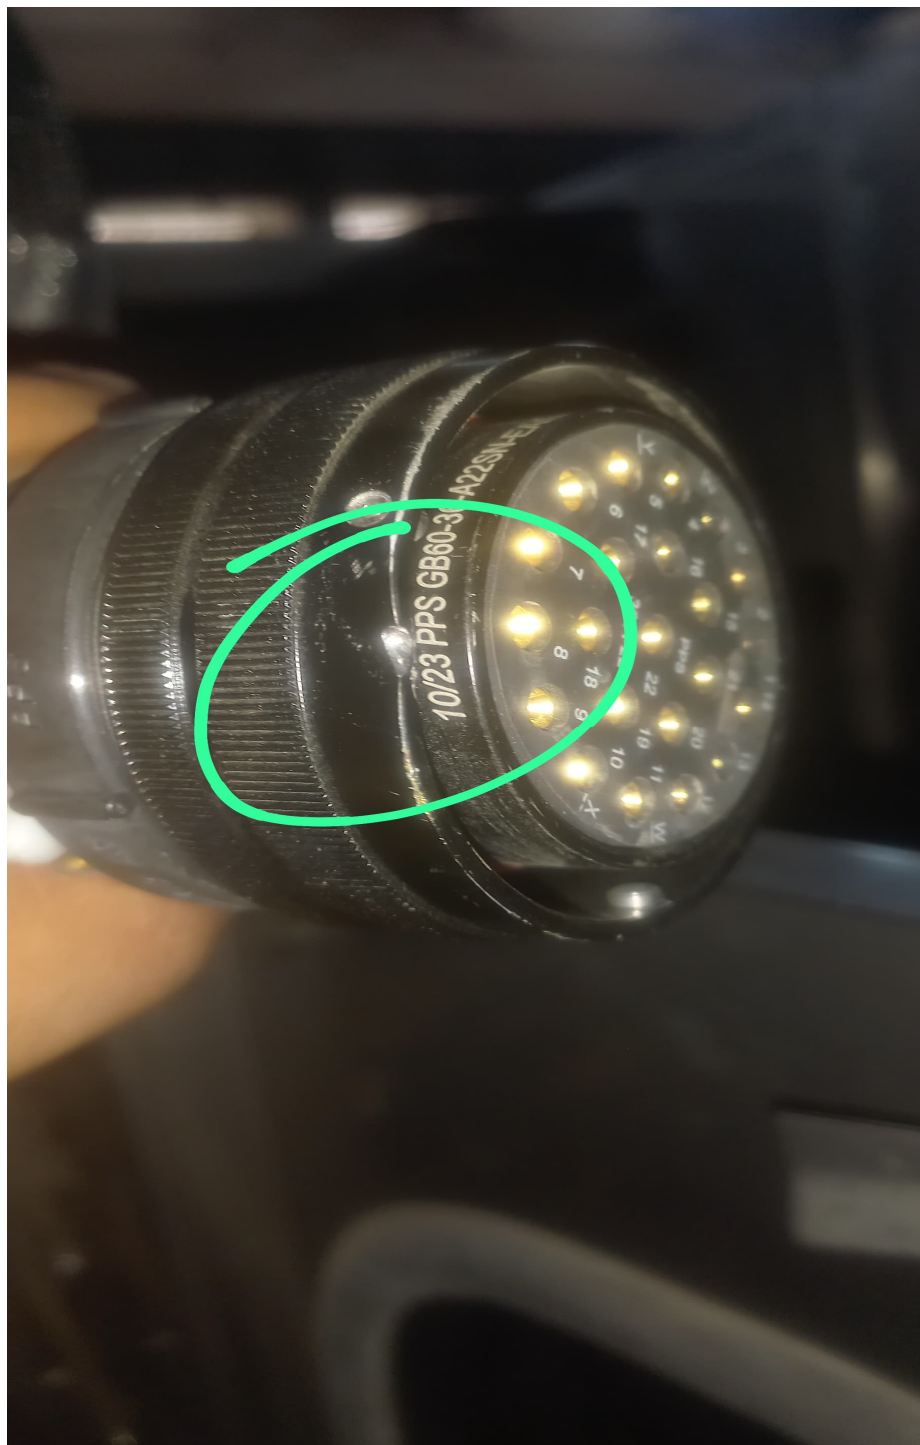
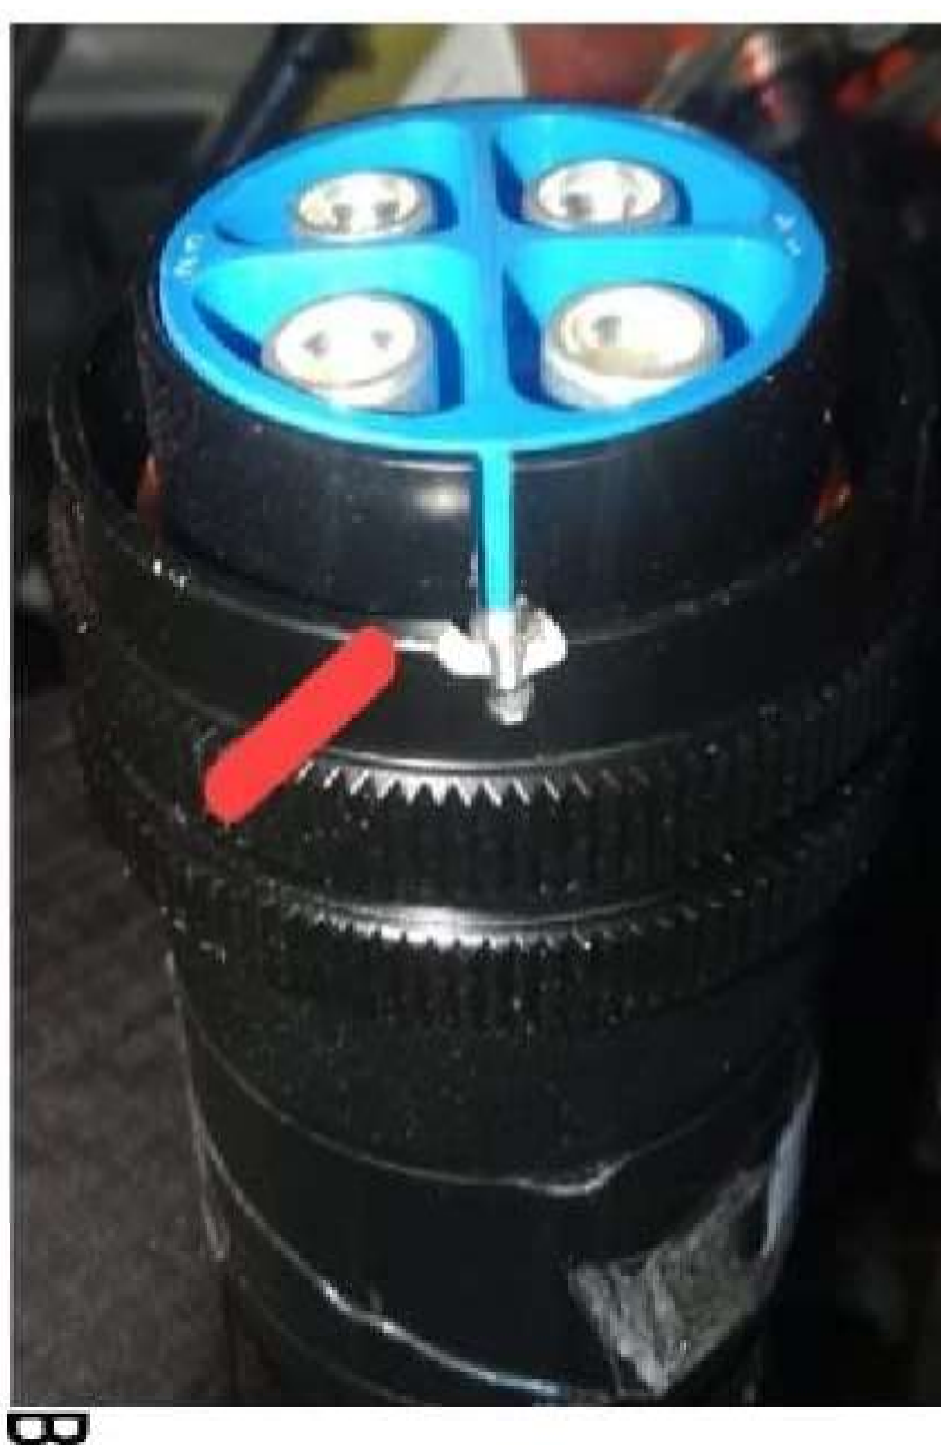
Photos of Defect in Supplied Harnessed Cable

Common Defects in Set of Harnessed Cables

- DTMS/Ferrule marking not provided/ Not good.
- Cable length is not accurate.
- Continuity test failure.
- Poor Quality Lug Crimping.
- Poor Quality of Connectors.
- Coupler ring broken.
- Neoprene hose torn/cracked.

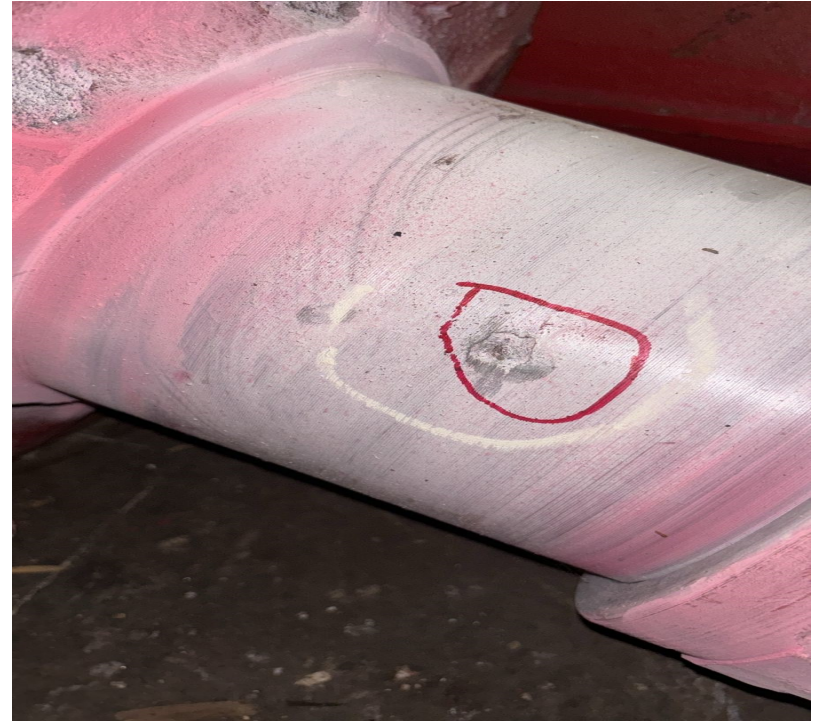
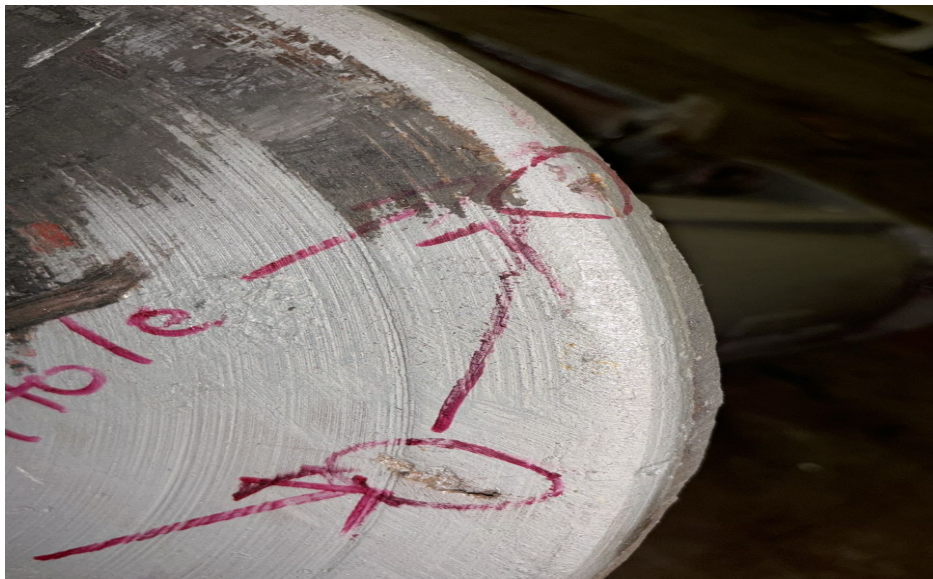
Common Defects in SIDE BUFFER Supplied by Suppliers

- Gap Found between base plate & rivet plate.
- Multiple blow hole observed on buffer.
- Hole observed on Plunger tube.
- Blow hole observed on rivet plate.
