PATIALA LOCOMOTIVE WORKS, PATIALA

HISTORY & TESTING RECORD OF 8W-DIESEL ELECTRIC TOWER CAR

DETC NO.	:M-460(250139)
TYPE	: 8 WHEELS
RAILWAY/DIVISION	: ECOR/SBPY
ELECTRIC TRACTION	: CGL
DATE OF DISPATCH	: 30.01.2026

PATIALA LOCOMOTIVE WORKS, PATIALA
Testing & Commissioning Format For 8W Diesel Electric Tower Car (DETC)

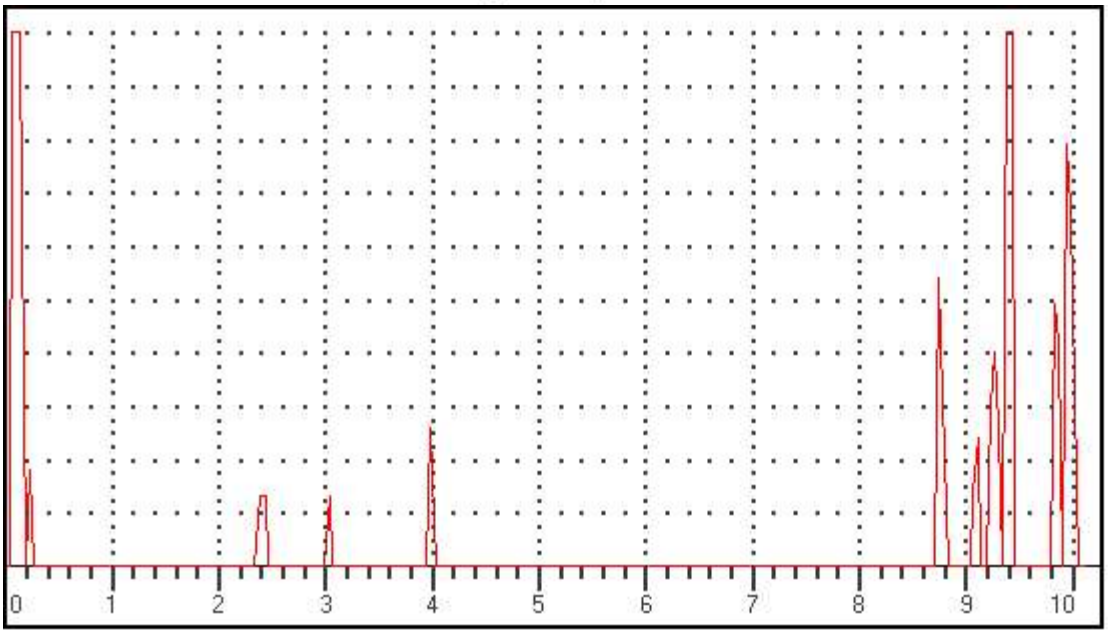
Date and Time.....:Dt:23/12/2025 Tm:9:40
UFD Model: Arya 1(R) Sr No:AA0362-4220
Railway/Workshop.....: BS PLW
Type of Axle/wheel....: DETC Axle/wheel No:02097
Operator Name/Code : CK MISHRA
Defect Location .....: GE
Test Results (Pass/Fail/other):
If other, then Remarks.....
Frame No: ASC01 *

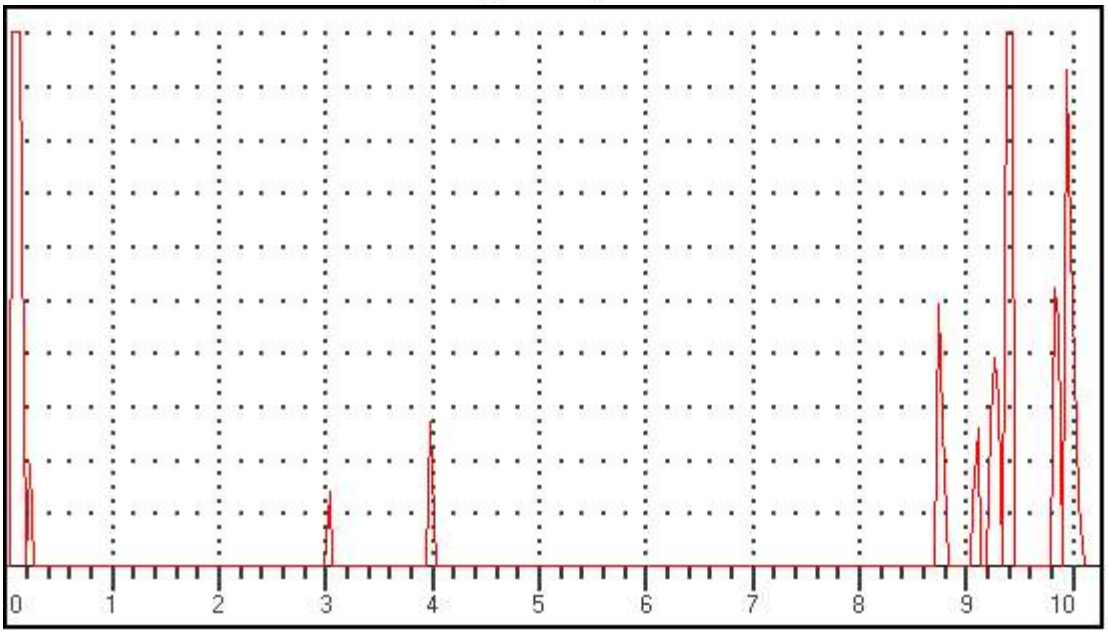
Gate 1 (Status): OFF
Gate 2 (Status): OFF
Gate 1(Echo height): 0 %
Gate 1(Beam Path): 0.00mm
Gate 1(Surface Distance): 0.00mm
Gate 1(Depth): 0.00mm
Gate 2(Echo height):
Gate 2(Beam Path): mm
Gate 2(Surface Distance): mm
Gate 2(Depth): mm

Date and Time.....:Dt:23/12/2025 Tm:9:40
UFD Model: Arya 1(R) Sr No:AA0362-4220
Railway/Workshop.....: BS PLW
Type of Axle/wheel....: DETC Axle/wheel No:02097
Operator Name/Code : CK MISHRA
Defect Location .....: GE
Test Results (Pass/Fail/other):
If other, then Remarks.....
Frame No: ASC02 *

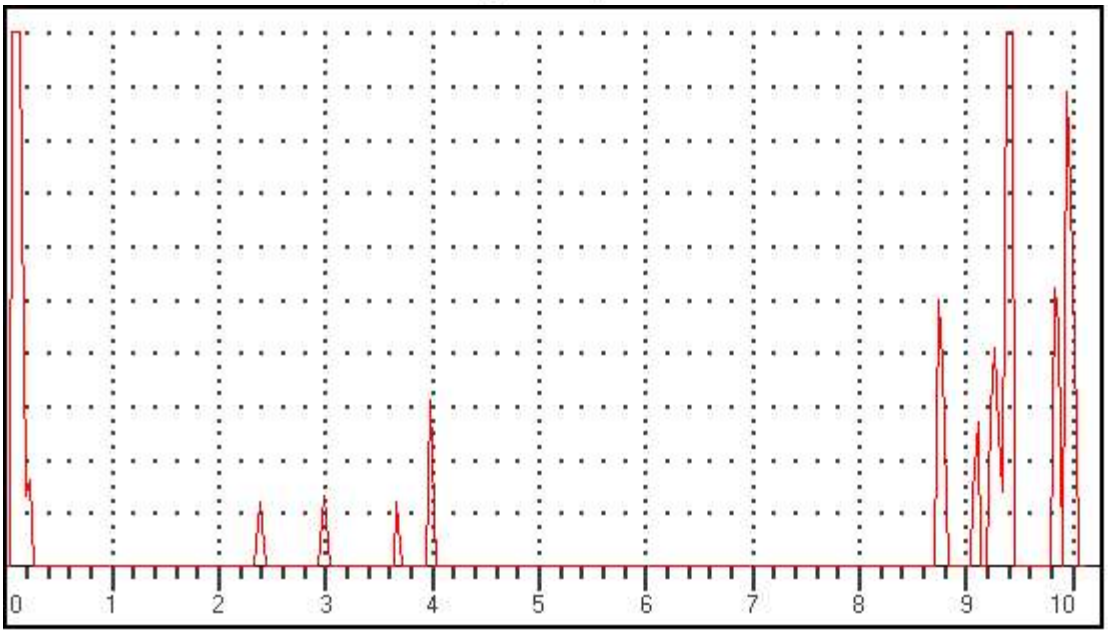
Gate 1 (Status): OFF
Gate 2 (Status): OFF
Gate 1(Echo height): 0 %
Gate 1(Beam Path): 0.00mm
Gate 1(Surface Distance): 0.00mm
Gate 1(Depth): 0.00mm
Gate 2(Echo height):
Gate 2(Beam Path): mm
Gate 2(Surface Distance): mm
Gate 2(Depth): mm

Date and Time.....:Dt:23/12/2025 Tm:9:41
UFD Model: Arya 1(R) Sr No:AA0362-4220
Railway/Workshop.....: BS PLW
Type of Axle/wheel....: DETC Axle/wheel No:02097
Operator Name/Code : CK MISHRA
Defect Location .....: GE
Test Results (Pass/Fail/other):
If other, then Remarks.....
Frame No: ASC03 *

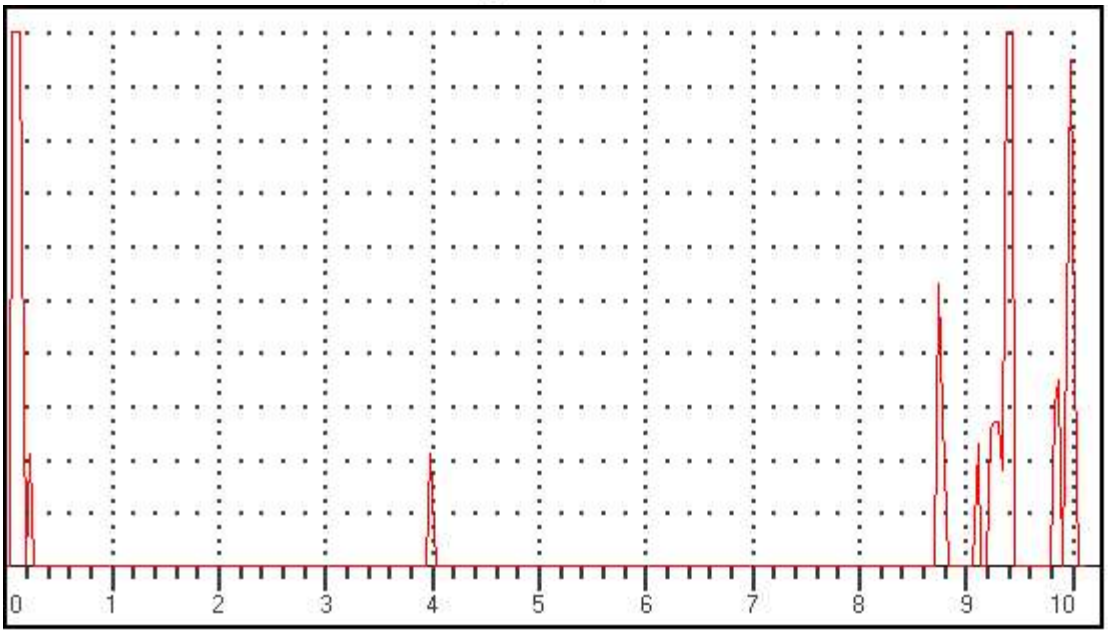
Gate 1 (Status): OFF
Gate 2 (Status): OFF
Gate 1(Echo height): 0 %
Gate 1(Beam Path): 0.00mm
Gate 1(Surface Distance): 0.00mm
Gate 1(Depth): 0.00mm
Gate 2(Echo height):
Gate 2(Beam Path): mm
Gate 2(Surface Distance): mm
Gate 2(Depth): mm

Date and Time.....:Dt:23/12/2025 Tm:9:41
UFD Model: Arya 1(R) Sr No:AA0362-4220
Railway/Workshop.....: BS PLW
Type of Axle/wheel....: DETC Axle/wheel No:02097
Operator Name/Code : CK MISHRA
Defect Location .....: GE
Test Results (Pass/Fail/other):
If other, then Remarks.....
Frame No: ASC04 *
