PATIALA Locomotive Works, Patiala

HISTORY & TESTING RECORD of 8W-Diesel ElEctric towEr car

DETC NO.	:240085 M-347
TYPE	: 8 Wheels
RAILWAY/Division	:sr/mdu
ELECTRIC TracTion	: govik
Date of Dispatch	: 21.02.2025

PROJECT	Diesel Electric Tower Car with Under-Slung Propulsion
CUSTOMER	SSE/TRD/MDU
DETC DMW NO.	**M-347 (240085)**
. **DETC RLY/SHED**	SR/MADURAI
Date of Dispatch	21/02/2025
Propulsion system	M/s. GOVIK Industries Ltd

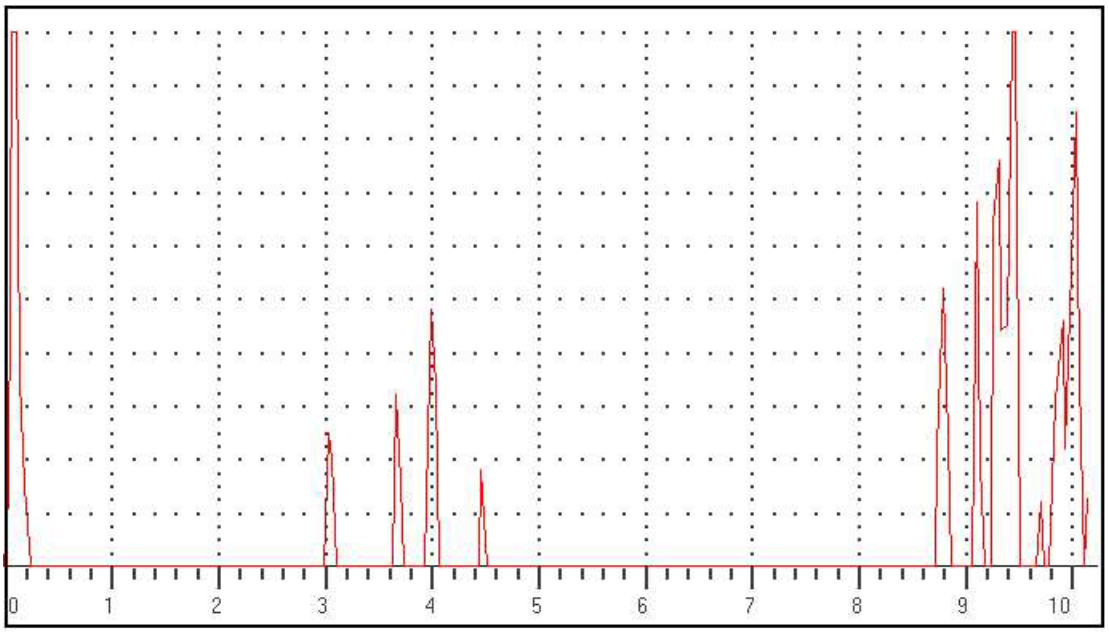
Date and Time.....:Dt:25/2/2025 Tm:11:43
UFD Model: Arya 1(R) Sr No:AA0362-4220
Railway/Workshop.....: BS PLW
Type of Axle/wheel.....: AD4433 Axle/wheel No:DETC
Operator Name/Code : RAMVEER MEENA
Defect Location .....: GE
Test Results (Pass/Fail/other):
If other, then Remarks.....
Frame No: ASC81 *

Gate 1 (Status): OFF
Gate 2 (Status): OFF
Gate 1(Echo height): 0 %
Gate 1(Beam Path): 0.00mm
Gate 1(Surface Distance): 0.00mm
Gate 1(Depth): 0.00mm
Gate 2(Echo height):
Gate 2(Beam Path): mm
Gate 2(Surface Distance): mm
Gate 2(Depth): mm

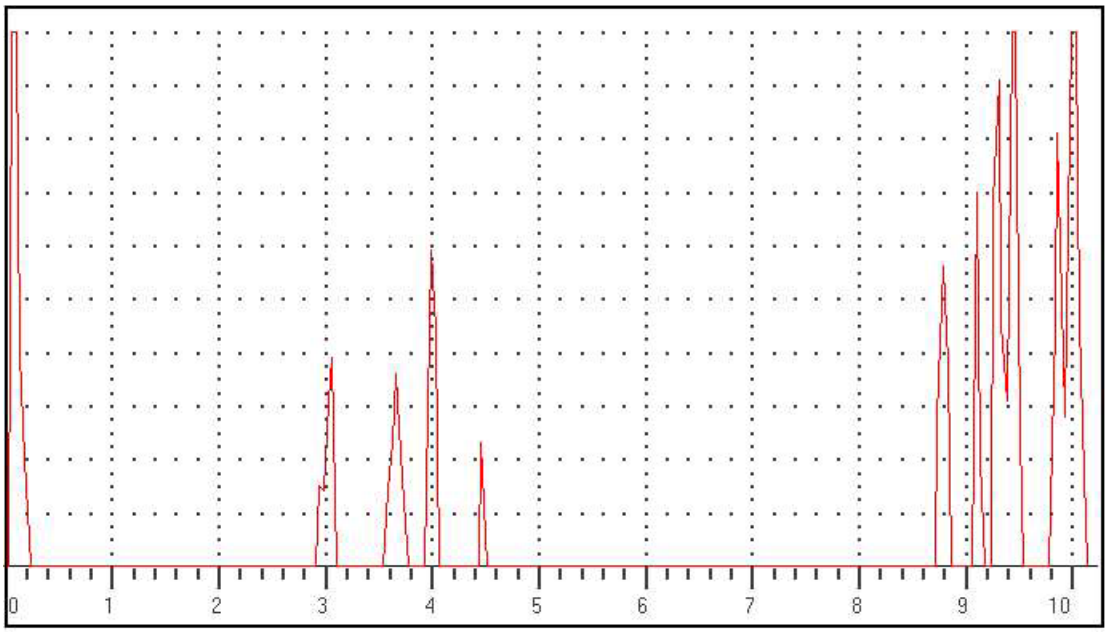
Date and Time.....:Dt:25/2/2025 Tm:11:43
UFD Model: Arya 1(R) Sr No:AA0362-4220
Railway/Workshop.....: BS PLW
Type of Axle/wheel.....: AD4433 Axle/wheel No:DETC
Operator Name/Code : RAMVEER MEENA
Defect Location .....: GE
Test Results (Pass/Fail/other):
If other, then Remarks.....
Frame No: ASC82 *

Gate 1 (Status): OFF
Gate 2 (Status): OFF
Gate 1(Echo height): 0 %
Gate 1(Beam Path): 0.00mm
Gate 1(Surface Distance): 0.00mm
Gate 1(Depth): 0.00mm
Gate 2(Echo height):
Gate 2(Beam Path): mm
Gate 2(Surface Distance): mm
Gate 2(Depth): mm

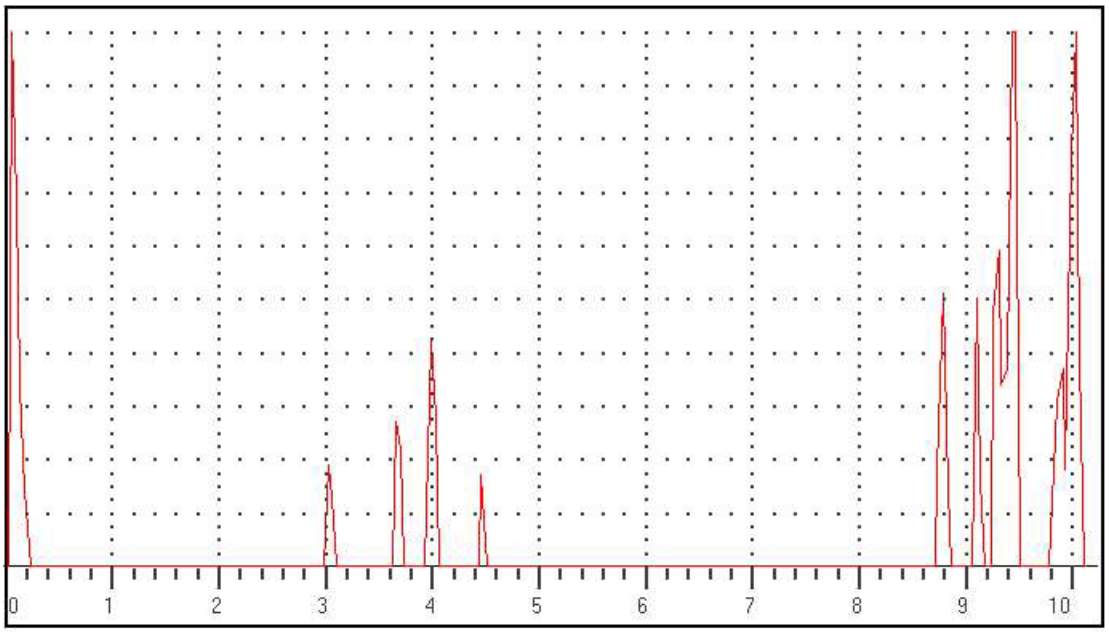
Date and Time.....:Dt:25/2/2025 Tm:11:44
UFD Model: Arya 1(R) Sr No:AA0362-4220
Railway/Workshop.....: BS PLW
Type of Axle/wheel.....: AD4433 Axle/wheel No:DETC
Operator Name/Code : RAMVEER MEENA
Defect Location .....: GE
Test Results (Pass/Fail/other):
If other, then Remarks.....
Frame No: ASC83 *

Gate 1 (Status): OFF
Gate 2 (Status): OFF
Gate 1(Echo height): 0 %
Gate 1(Beam Path): 0.00mm
Gate 1(Surface Distance): 0.00mm
Gate 1(Depth): 0.00mm
Gate 2(Echo height):
Gate 2(Beam Path): mm
Gate 2(Surface Distance): mm
Gate 2(Depth): mm

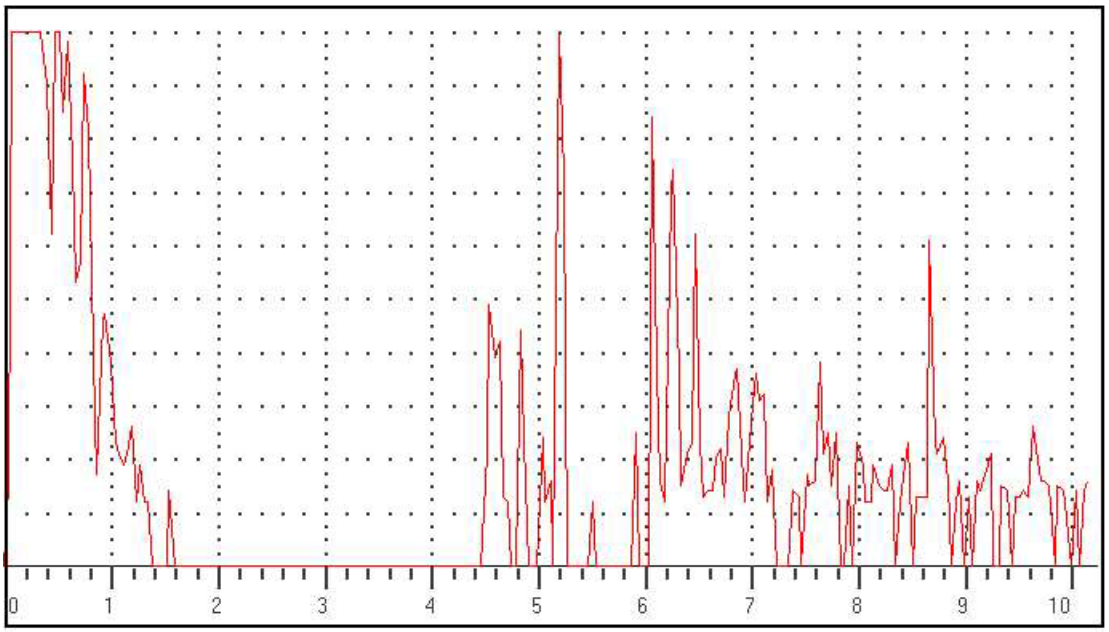
Date and Time.....:Dt:25/2/2025 Tm:11:44
UFD Model: Arya 1(R) Sr No:AA0362-4220
Railway/Workshop.....: BS PLW
Type of Axle/wheel.....: AD4433 Axle/wheel No:DETC
Operator Name/Code : RAMVEER MEENA
Defect Location .....: GE
Test Results (Pass/Fail/other):
If other, then Remarks.....
Frame No: ASC84 *

Gate 1 (Status): OFF
Gate 2 (Status): OFF
Gate 1(Echo height): 0 %
Gate 1(Beam Path): 0.00mm
Gate 1(Surface Distance): 0.00mm
Gate 1(Depth): 0.00mm
Gate 2(Echo height):
Gate 2(Beam Path): mm
Gate 2(Surface Distance): mm
Gate 2(Depth): mm

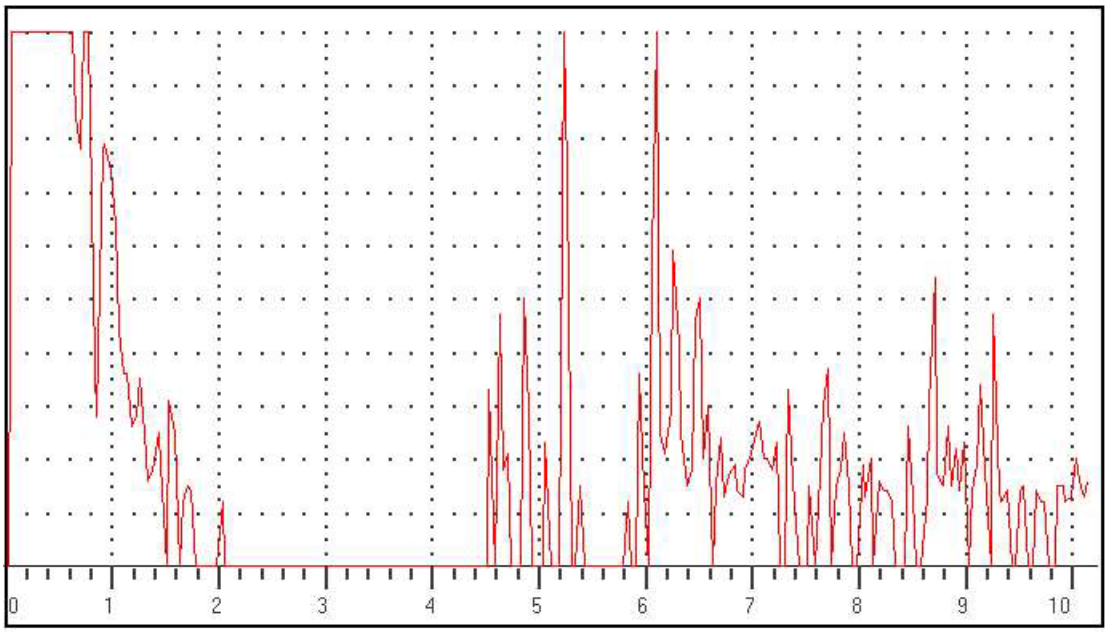
Date and Time.....:Dt:25/2/2025 Tm:11:45
UFD Model: Arya 1(R) Sr No:AA0362-4220
Railway/Workshop.....: BS PLW
Type of Axle/wheel.....: AD4433 Axle/wheel No:DETC
Operator Name/Code : RAMVEER MEENA
Defect Location .....: GE
Test Results (Pass/Fail/other):
If other, then Remarks.....
Frame No: ASC85 *

Gate 1 (Status): PLOGIC
Gate 2 (Status): OFF
Gate 1(Echo height): 0 %
Gate 1(Beam Path): 0.00mm
Gate 1(Surface Distance): 0.00mm
Gate 1(Depth): 0.00mm
Gate 2(Echo height):
Gate 2(Beam Path): mm
Gate 2(Surface Distance): mm
Gate 2(Depth): mm
